Vulnerability of the north Alaska Highway to permafrost thaw

Design options and climate change adaptation

F. Calmels, Doré, G., Kong, X., Roy, L., Lemieux, C., Horton, B., 2016. Vulnerability of the north Alaska Highway to permafrost thaw: Design options and climate change adaptation. Northern Climate ExChange, Yukon Research Centre, Yukon College, 130 p.

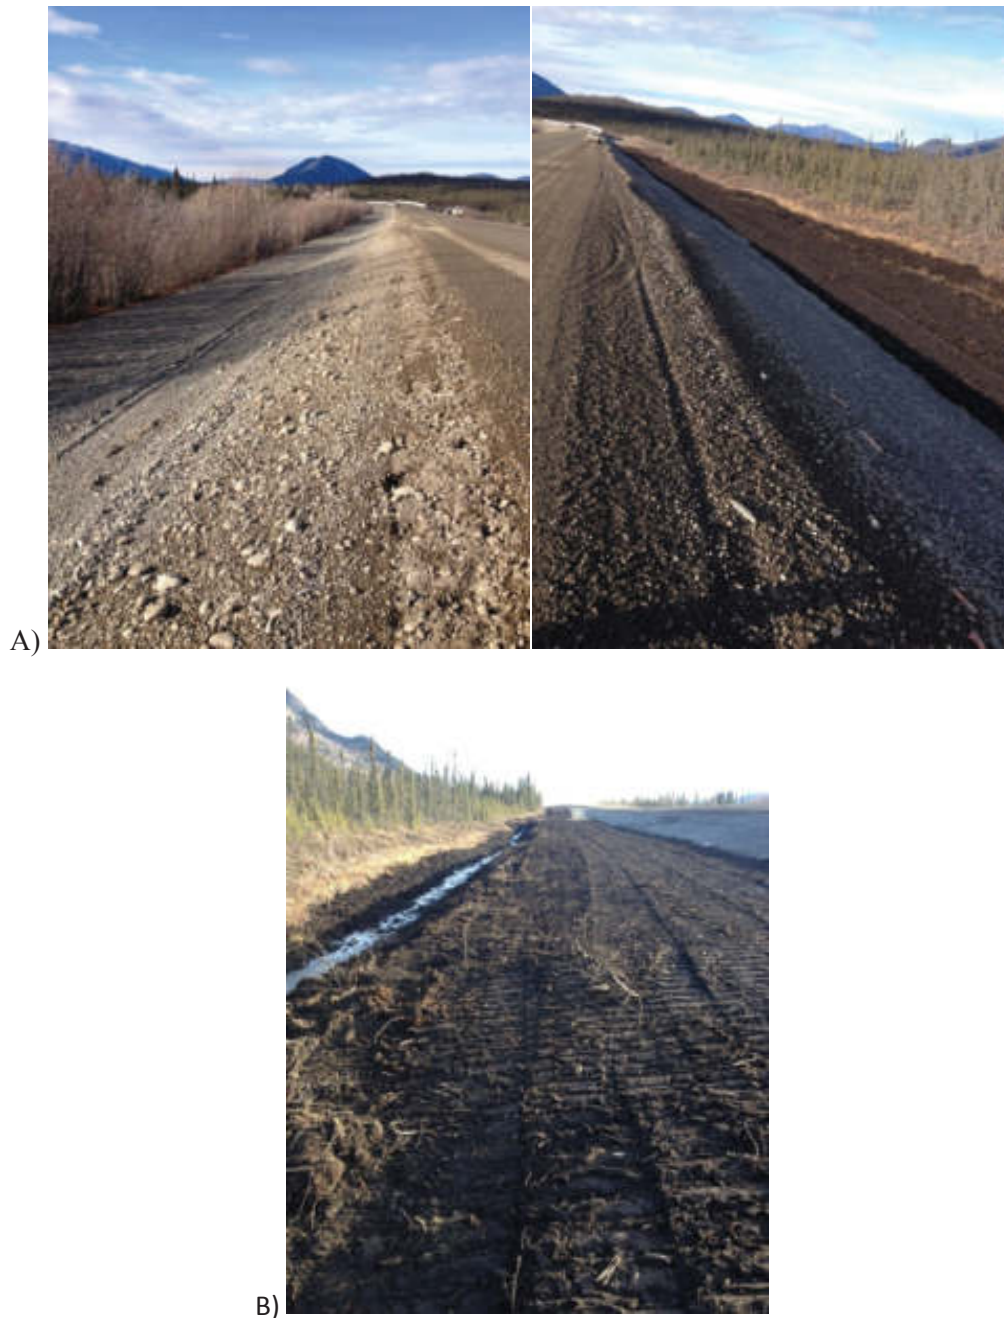
The black topsoil on the right side of embankment was laid in September 2015 using the material removed from the ditch (Figure 4.1.8.). While this topsoil will increase heat intake in the ground at the toe of the embankment during the few first years, vegetation cover will develop and progressively contribute to ground cooling along the embankment.

Figure 4.1.8. Koidern No. 2 adaptation site, km 1810.2 for A) Left and right sides of the embankment, facing north; B) Right side of the embankment, facing south.

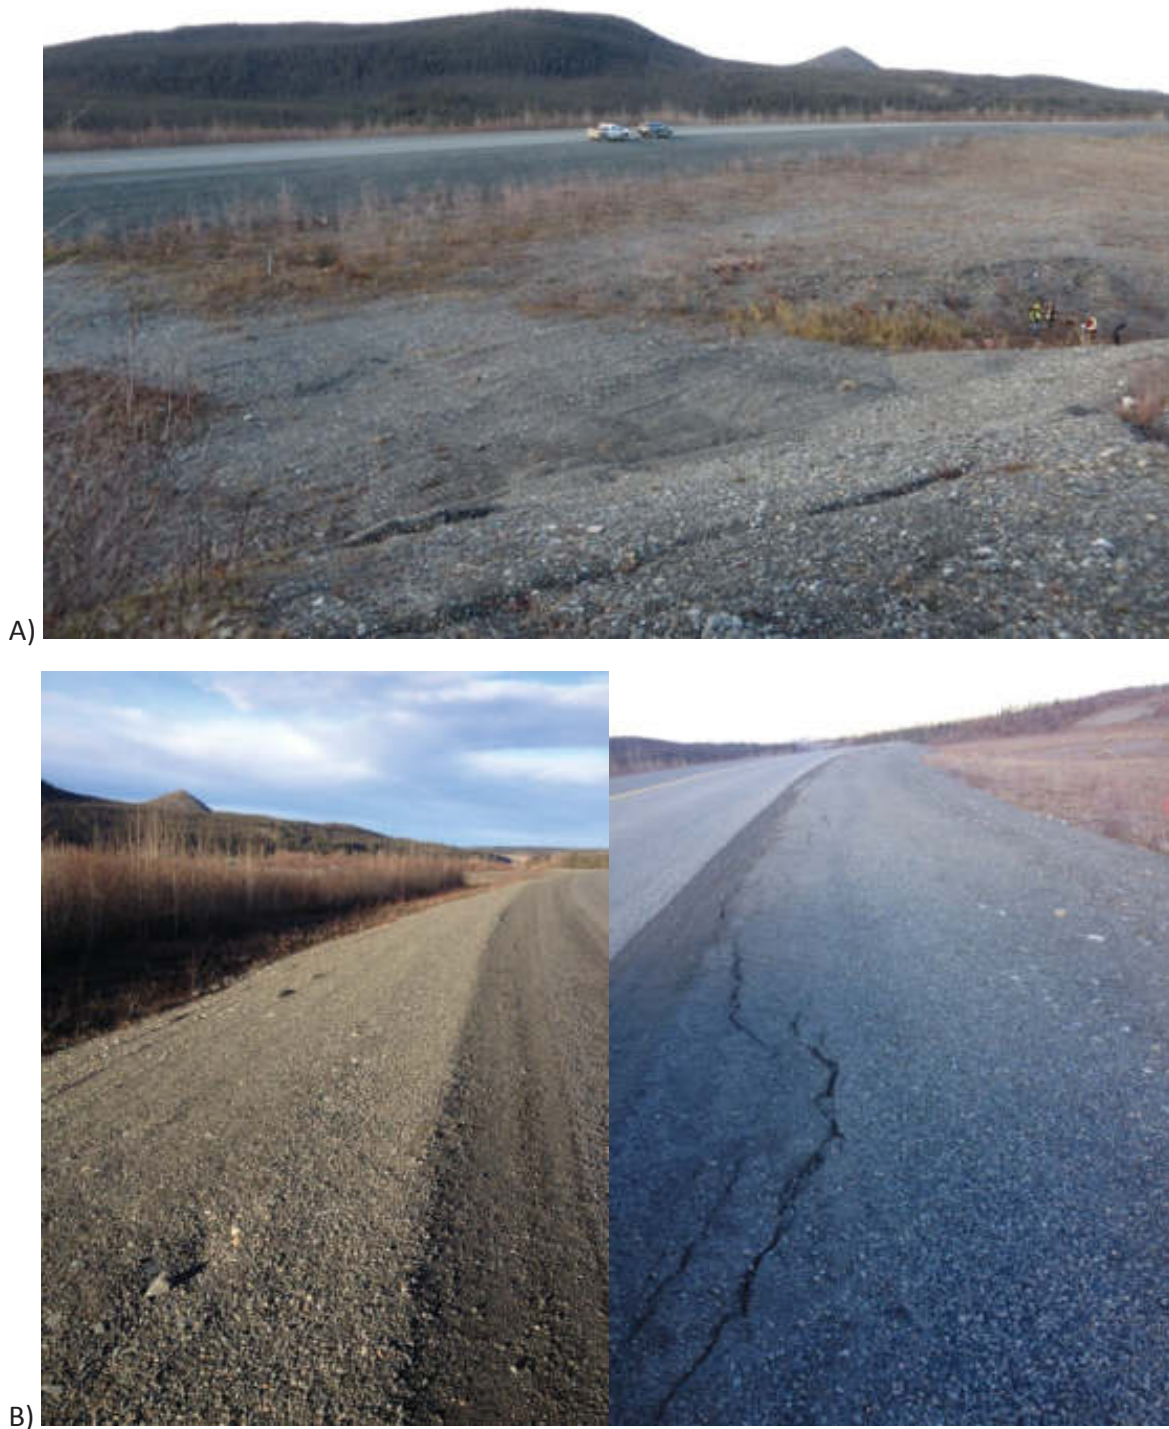
A large thermokarst pond is present on the Left Hand Side of the road. Its formation is attributable to the melting of a substantial amount of ground ice thaw following the construction activities.

Figure 4.2.11. Dry Creek adaptation site, km 1841.3 for A) General view of the site, facing west; and B) Left and right hand sides of the embankment, facing north

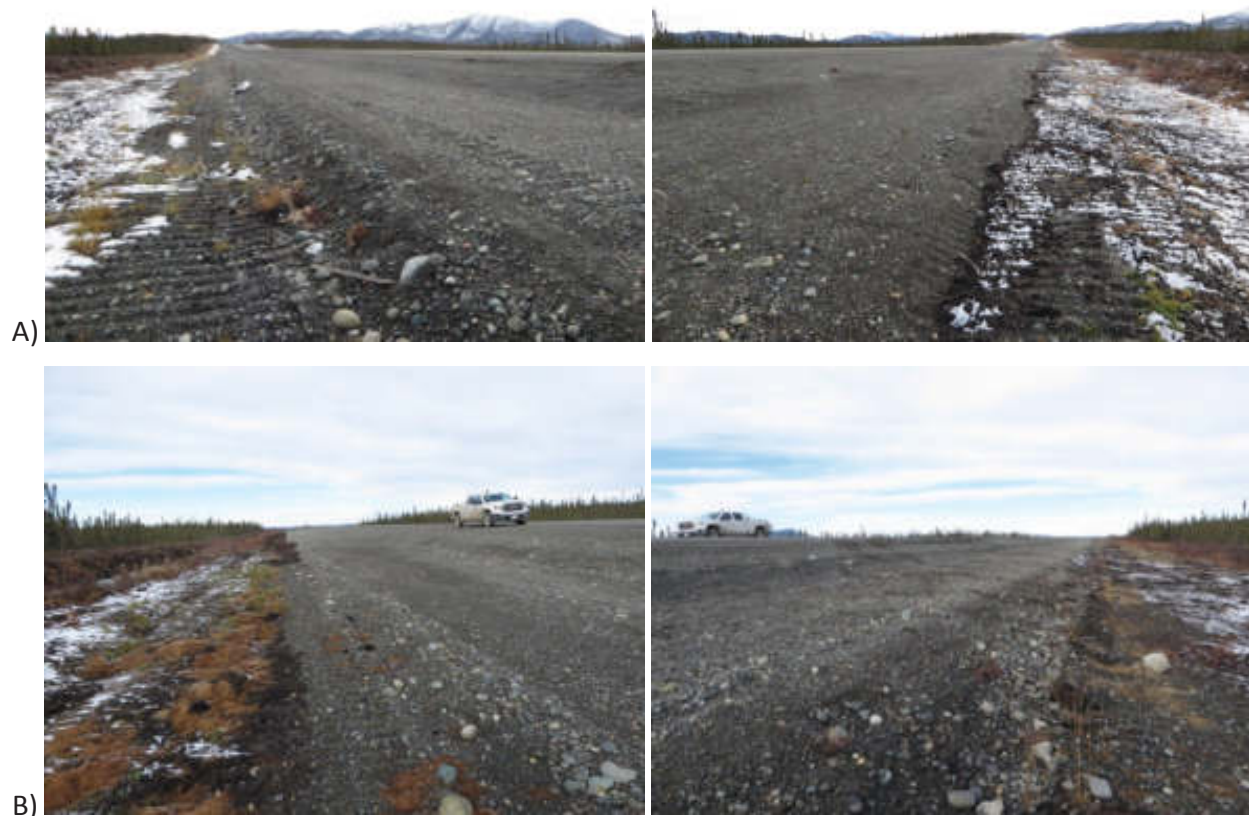
This road passes through a forested area and only the areas along the road are vegetation-free (Figure 4.3.8). Specifically, between the toe of the embankment and the ditches on both sides, the only vegetation is scarce grass, while the tree coverage outside the ditches is relatively thick.

Figure 4.3.8. Enger Creek adaptation site for A) Left and right sides of the embankment facing south; and B) Right and left sides of the embankment facing north.

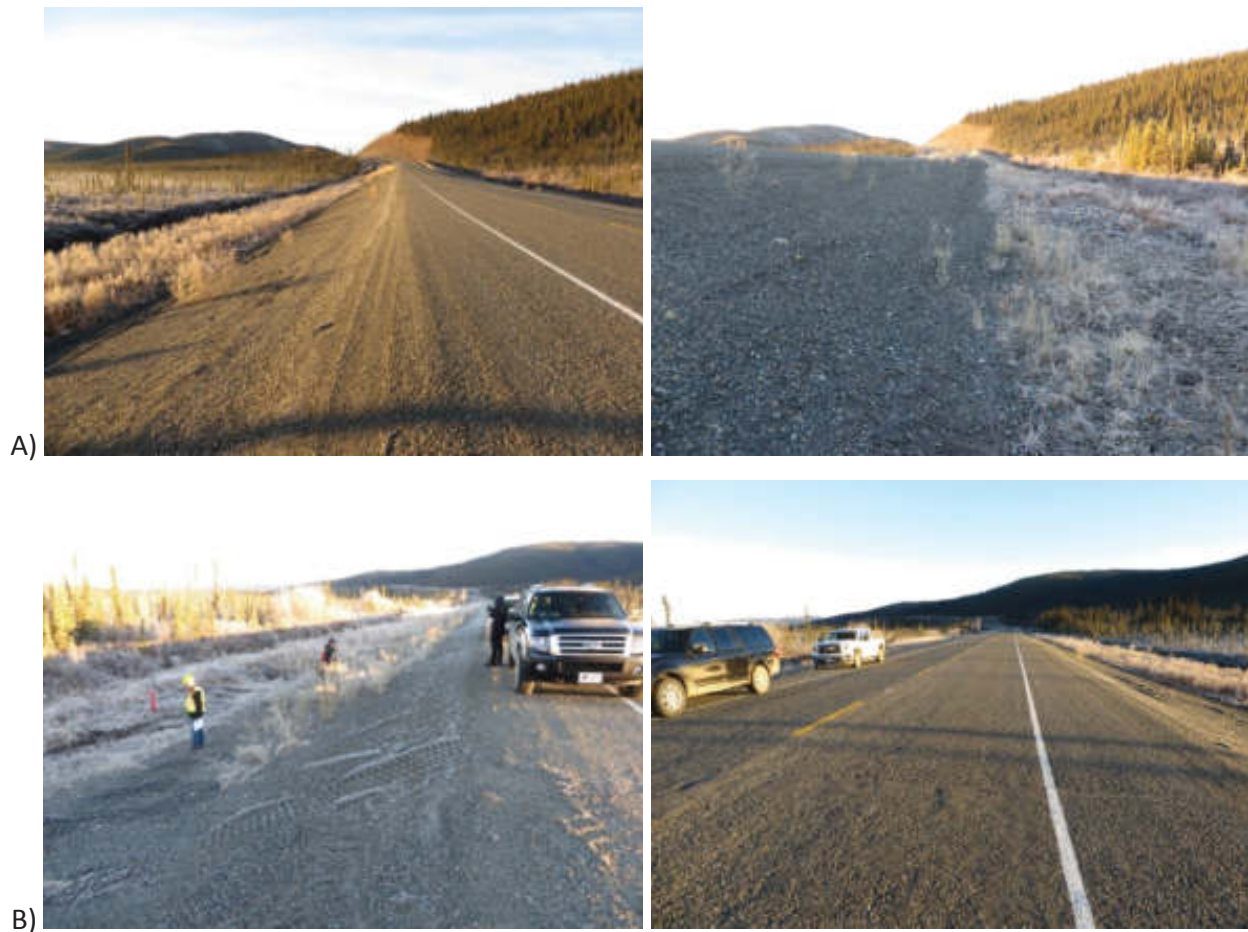
The areas between the toe of the embankment and the ditches are partly covered by grass, shrubs and other plants. Outside the ditches, the site is characterized by a higher concentration of trees and shrubs. The trees have lower density than the shrubs.

Figure 4.4.10 North to Beaver Creek adaptation site, km 1896 for A) Left side and right sides of the embankment, facing south; and B) Right side and left sides of the embankment, facing north.

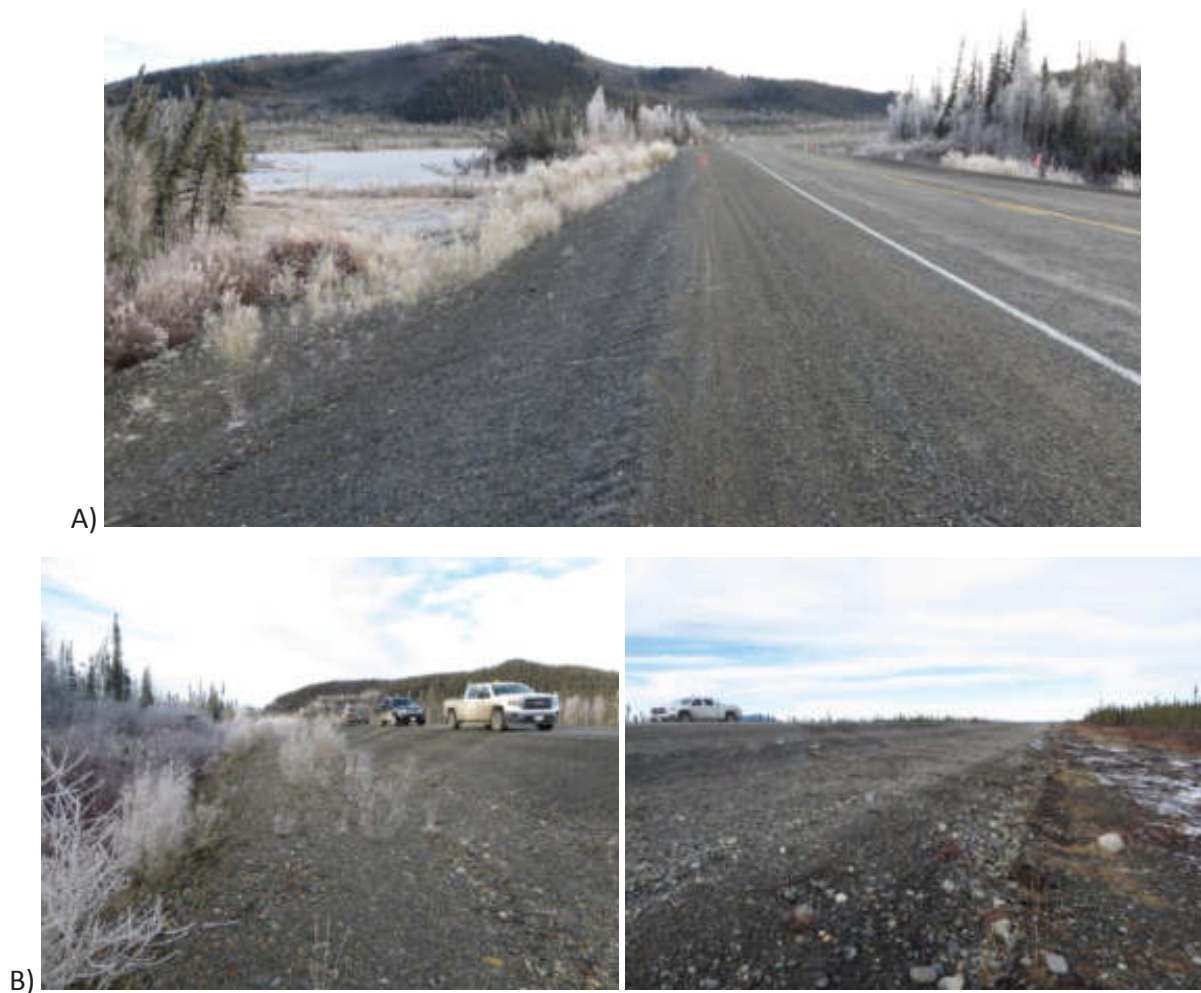
Bogs are present along the left side, they developed in the meanders of a relict fluvial system. Most of the terrain of this site is covered by vegetation, except in the areas along the road where sparse grass and shrubs can be observed (Figure 3.5.11).

Figure 3.5.11 Mirror Creek adaptation site, km 1886 for A) Right side of the embankment, facing south; and B) Left and right sides of the embankment, facing north.

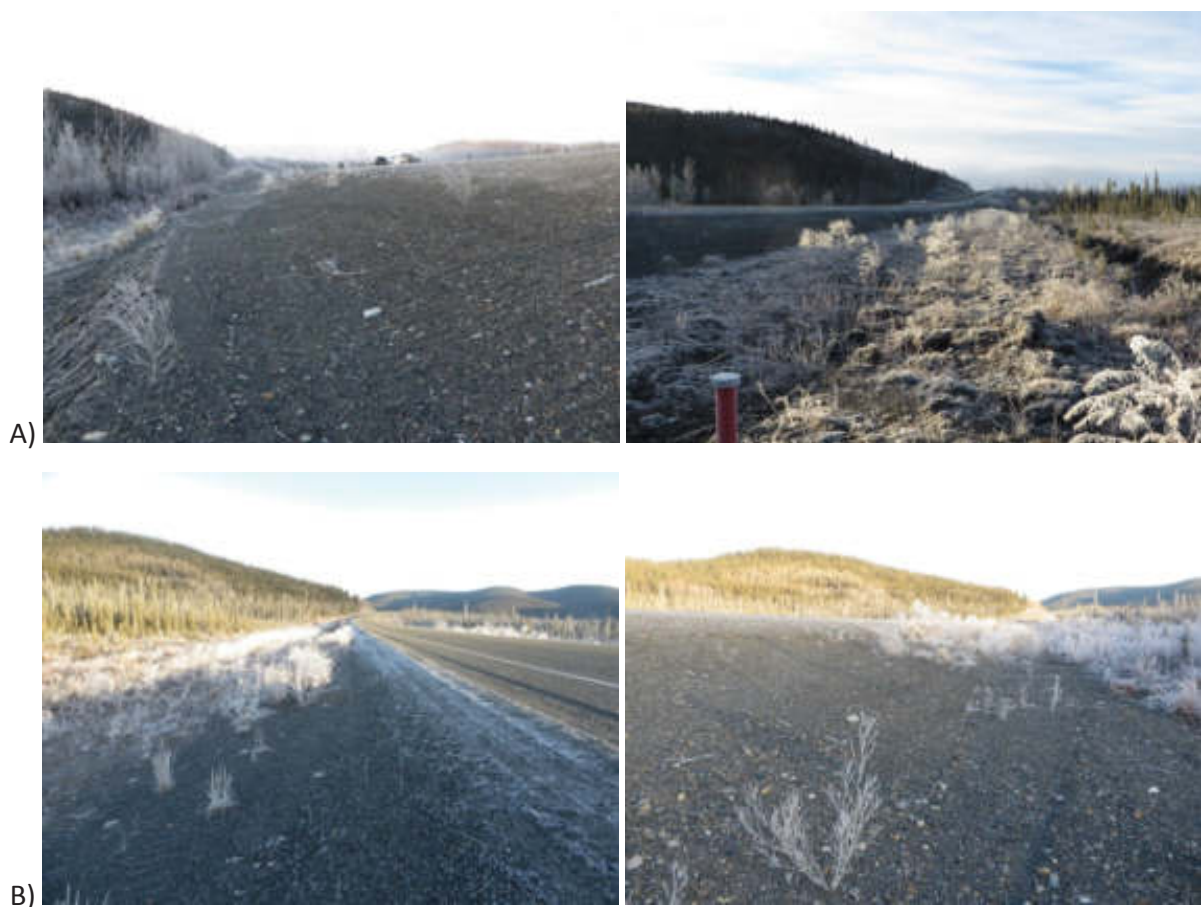
Some notable features of this site are two ditches that were dug in 2013, parallel to the road. The distance between the toe of the embankment and the ditches, are about 12 m at the left hand side, and 10 m at the right hand side. They are 4 m wide and 1.5 m deep, the shortest one being at the right hand side (Figure 4.6.9). A camera has been fixed near the long ditch to monitor the development of the ditch slump. The result shows that this ditch is strongly affected by thermal erosion and is becoming wider (Figure 4.6.10). A stream (① in Figure 4.6.9A) is intercepted by the ditch at the left hand side, flowing perpendicular to the ditch. Yet the ditch cut an ice wedge, at the same level as the stream that is also perpendicular to the ditch and the embankment. From spring to fall, the stream is fed by runoff water, and erodes the ice wedge. Now, thermal erosion has developed and is incising the terrain starting from the ditch to the west, exposing additional ice-rich permafrost and wedge ice. Besides stream (①), water also was flowing through culverts (② and ③ in Figure 4.6.9A) at the time of site visit in October 2015.

Figure 4.6.10. North of Beaver Creek adaptation site, km 1895 for A) Right and left sides of the embankment, facing south; and B) Left and right sides of the embankment, facing north

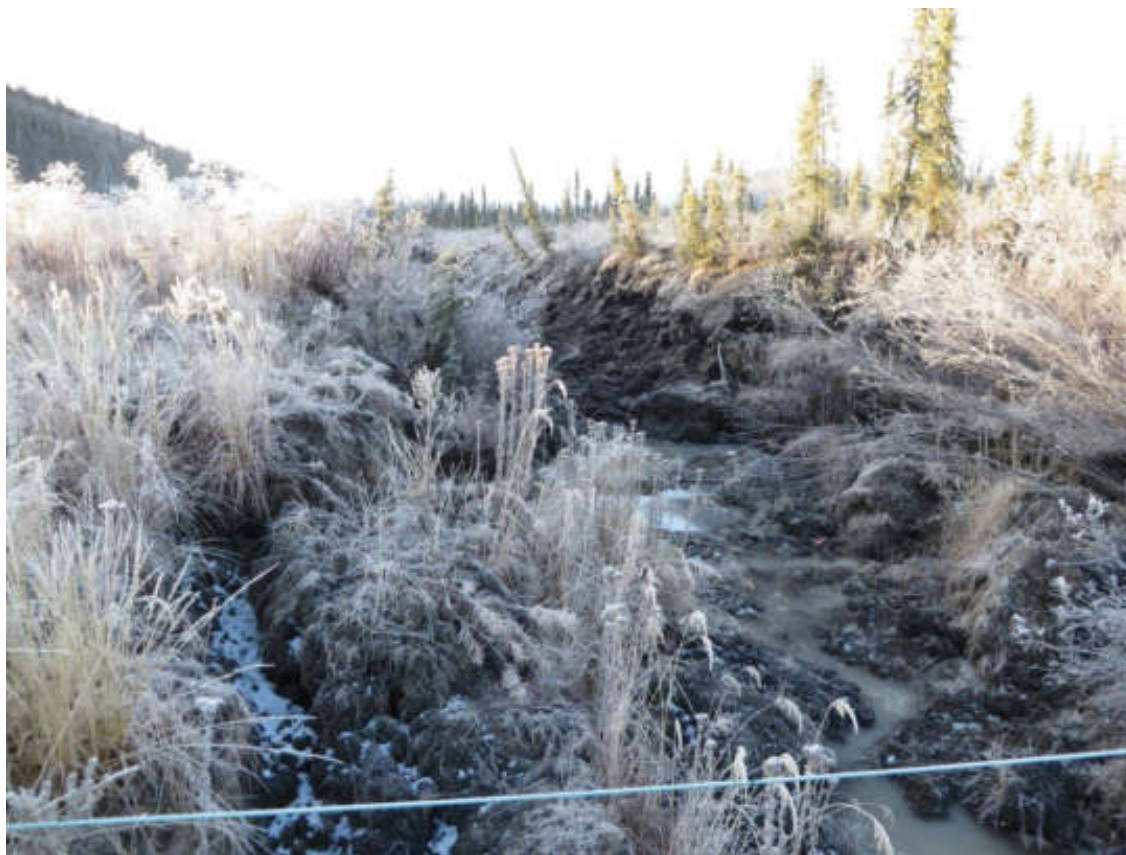
Figure 4.6.11. Thermal erosion in the ditch, facing southwest.
