**PRELIMINARY SURVEY AND FIELD RECORDING
NORTH FORK POWER PROJECT**

DAWSON CITY MUSEUM AND HISTORICAL SOCIETY

**Barbara Hogan and Gregory Skuce
August 1992**

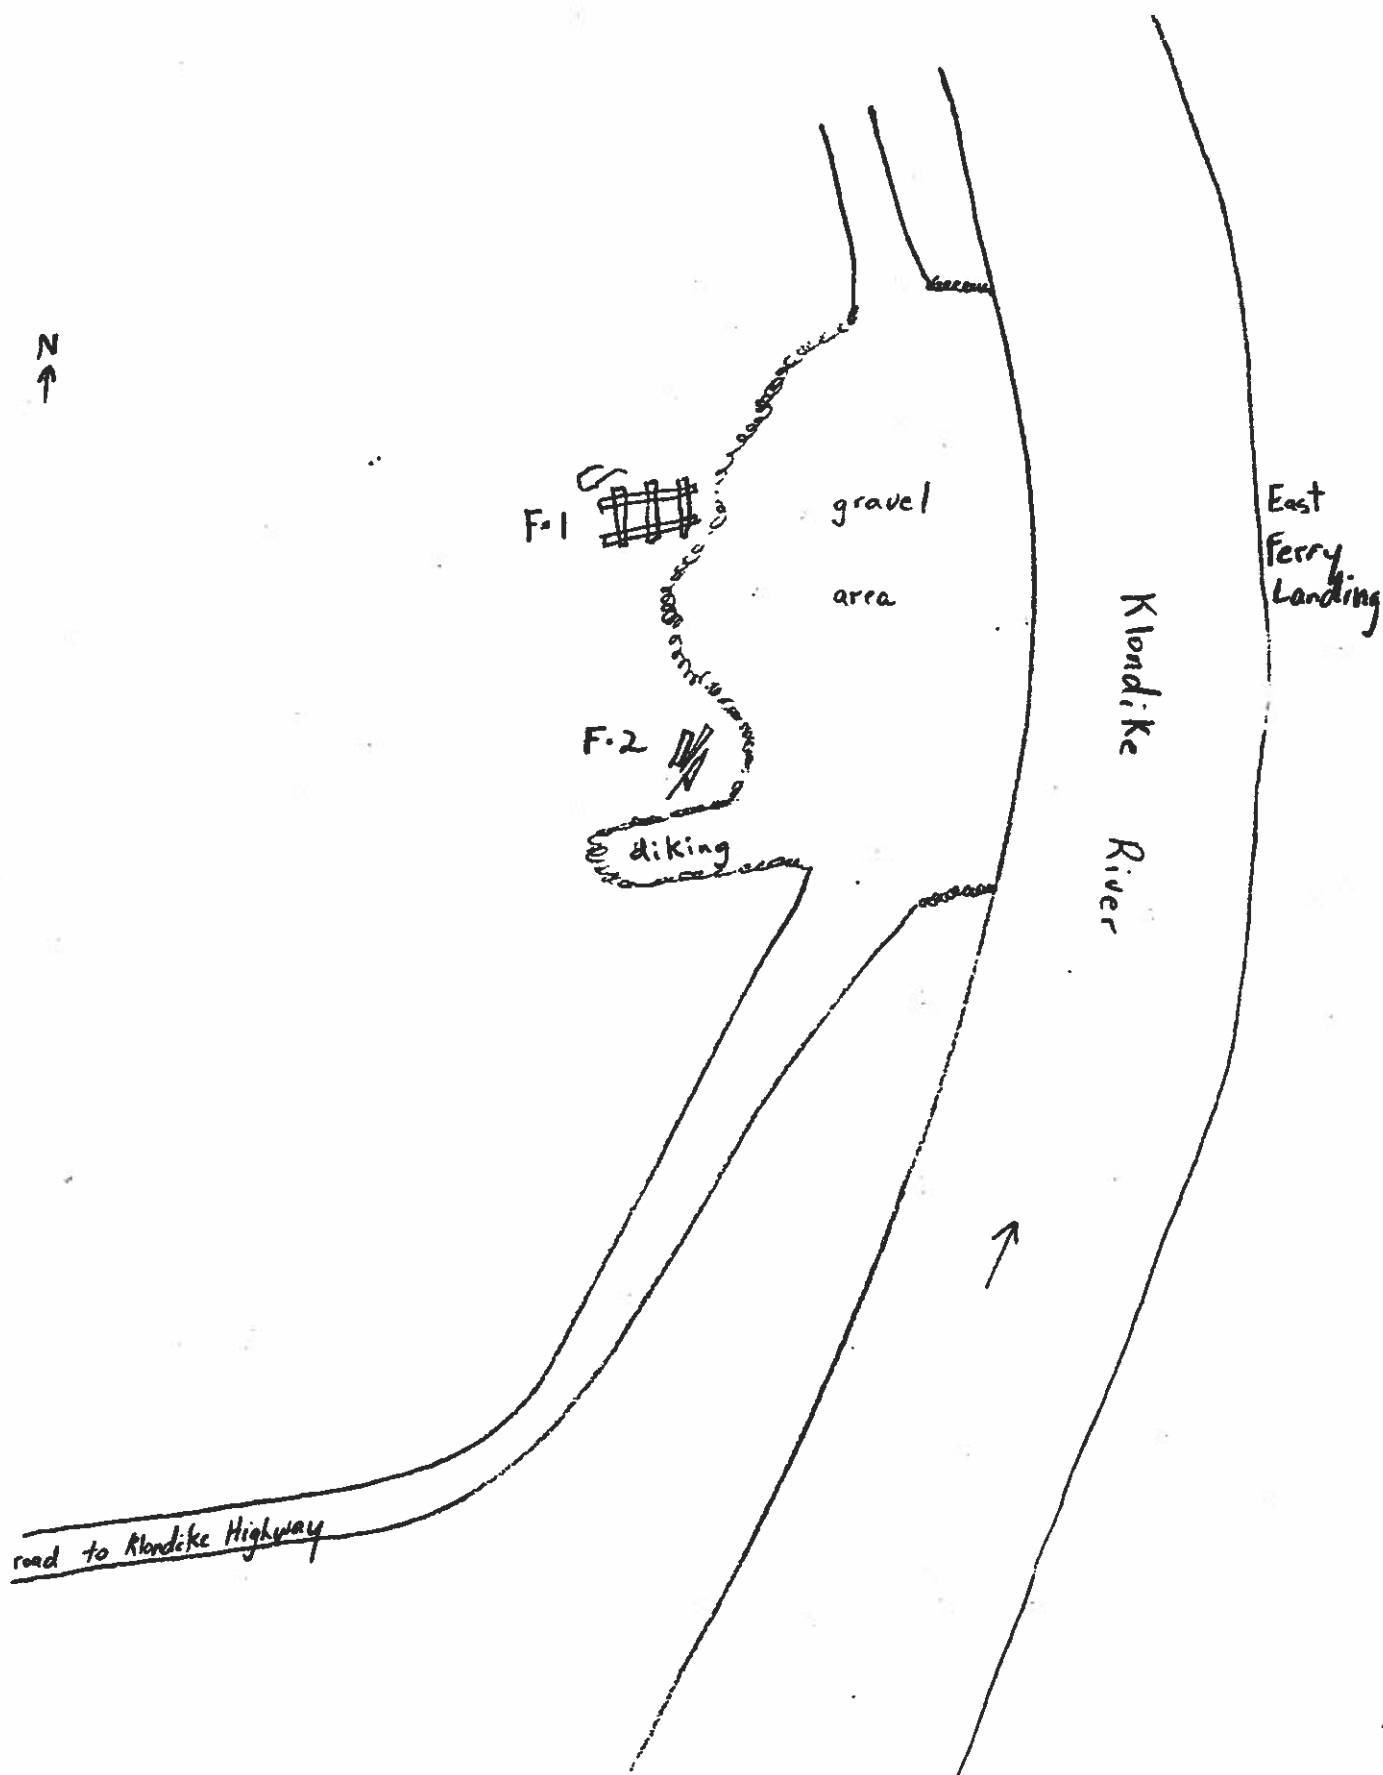
Feature One: scattered beams bolted together with cable, probably the ferry tower used in conjunction with the cable ferry. Poor condition.

Feature Two: scattered grey planks in a mound of dirt. Poor condition. Possibly connected with the ferry tower.

F-1: pieces of tower

F-2: foundation and planks

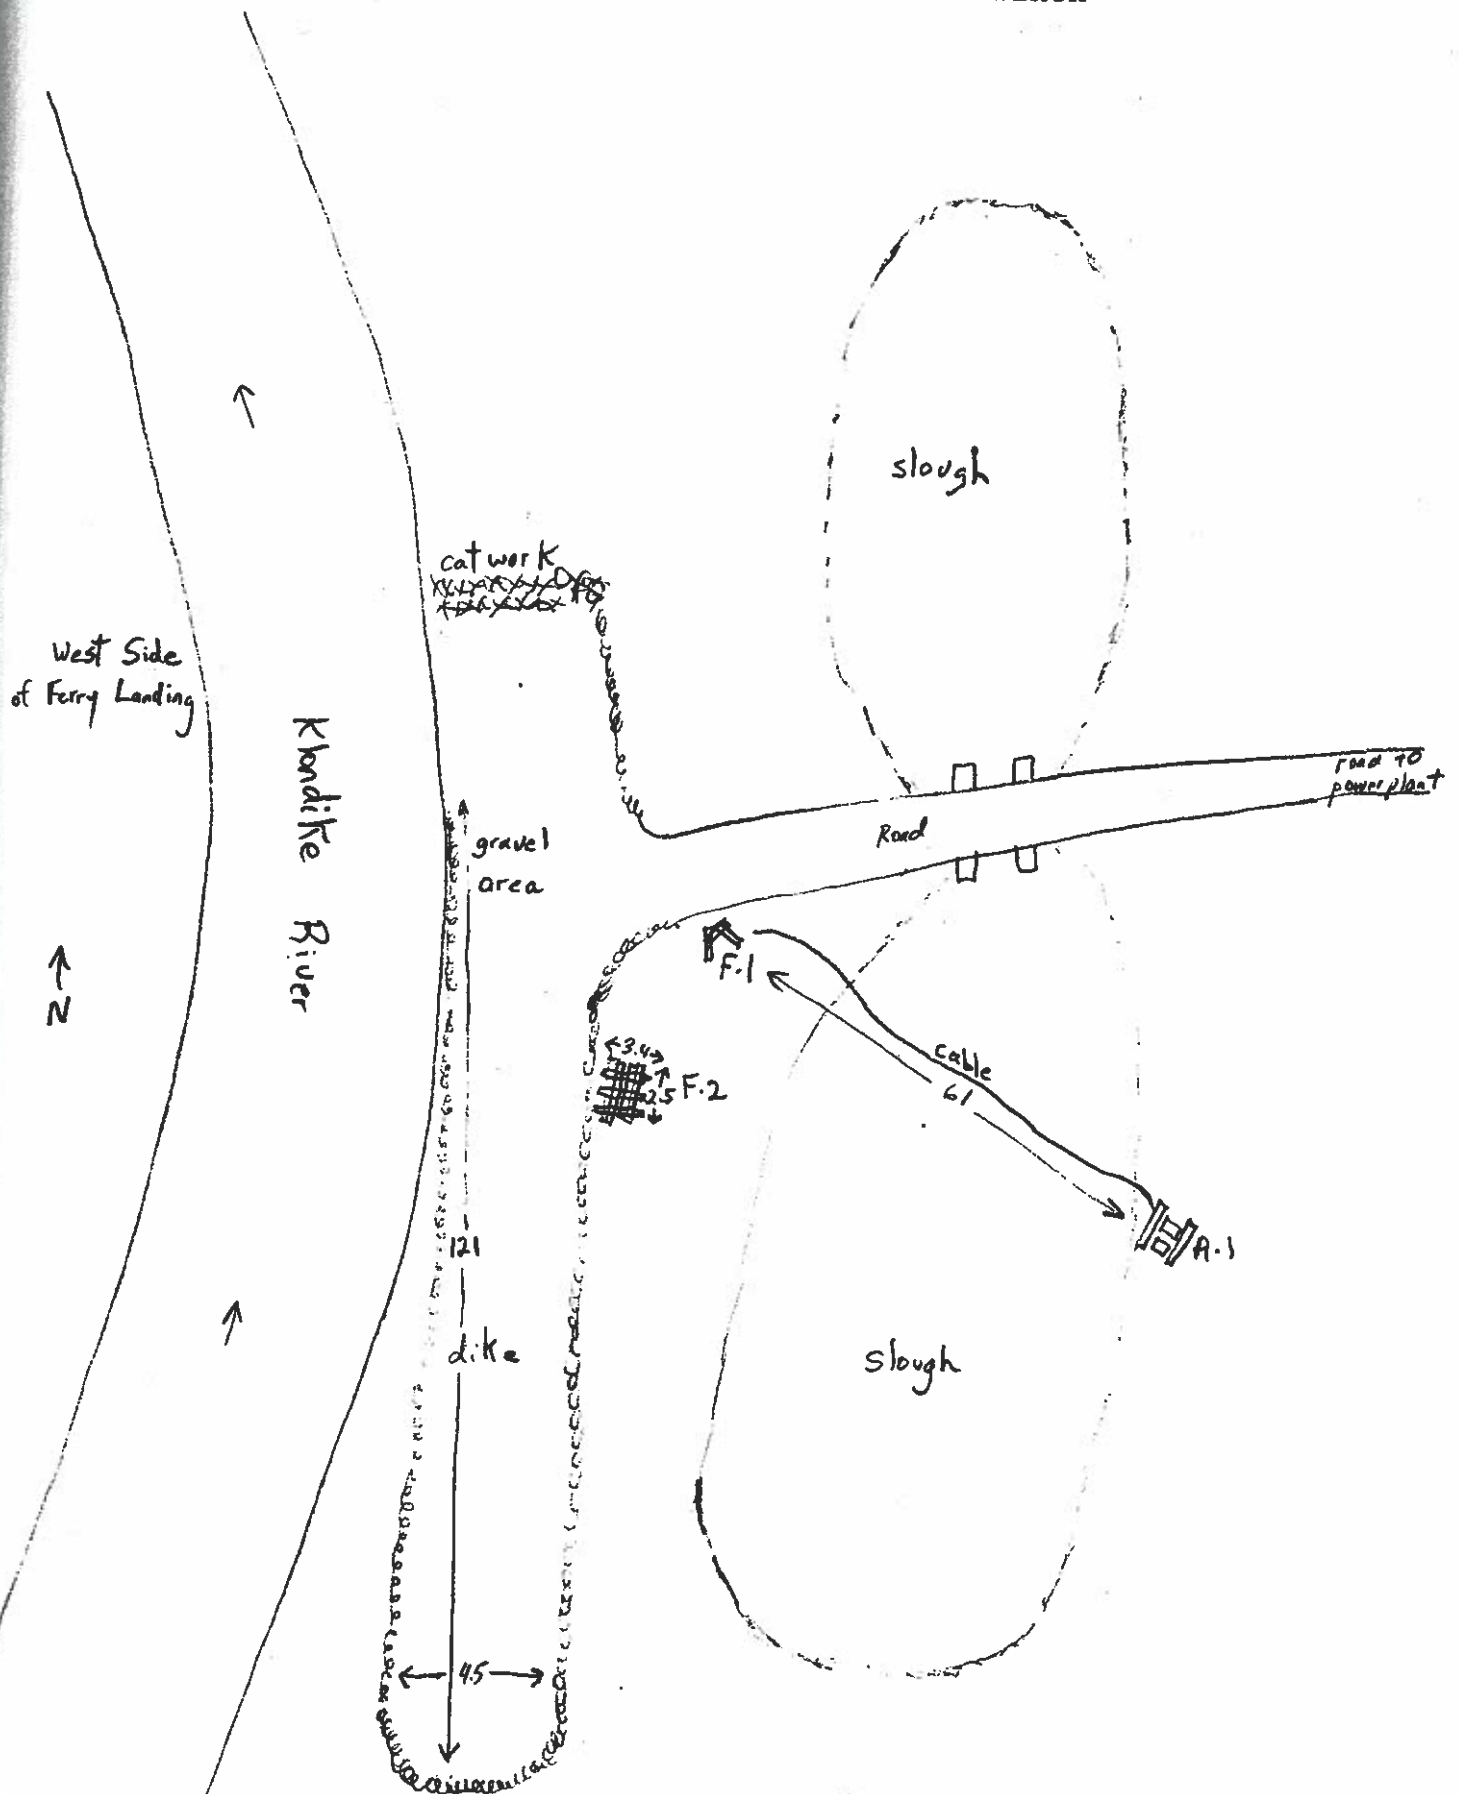
SITE 2

Feature One: bolted boards and 1 " cable. Poor condition. Probably part of the cable tower used with the cable ferry.

Feature Two: ferry from the cable ferry. Poor condition. Constructed from milled lumber and logs. Wood rotted. Used to transport men and equipment across the Klondike River to the Yukon Consolidated Gold Company camps before the Dempster Highway was built.

Artifact One: Winch used in conjunction with the cable ferry. Fair condition, buried beneath a windrow of trees and dirt. Likely used in conjunction with the cable ferry, to wind the cable in to move the ferry across the Klondike River.

F-1: pieces of tower
F-2: old ferry
A-1: winch

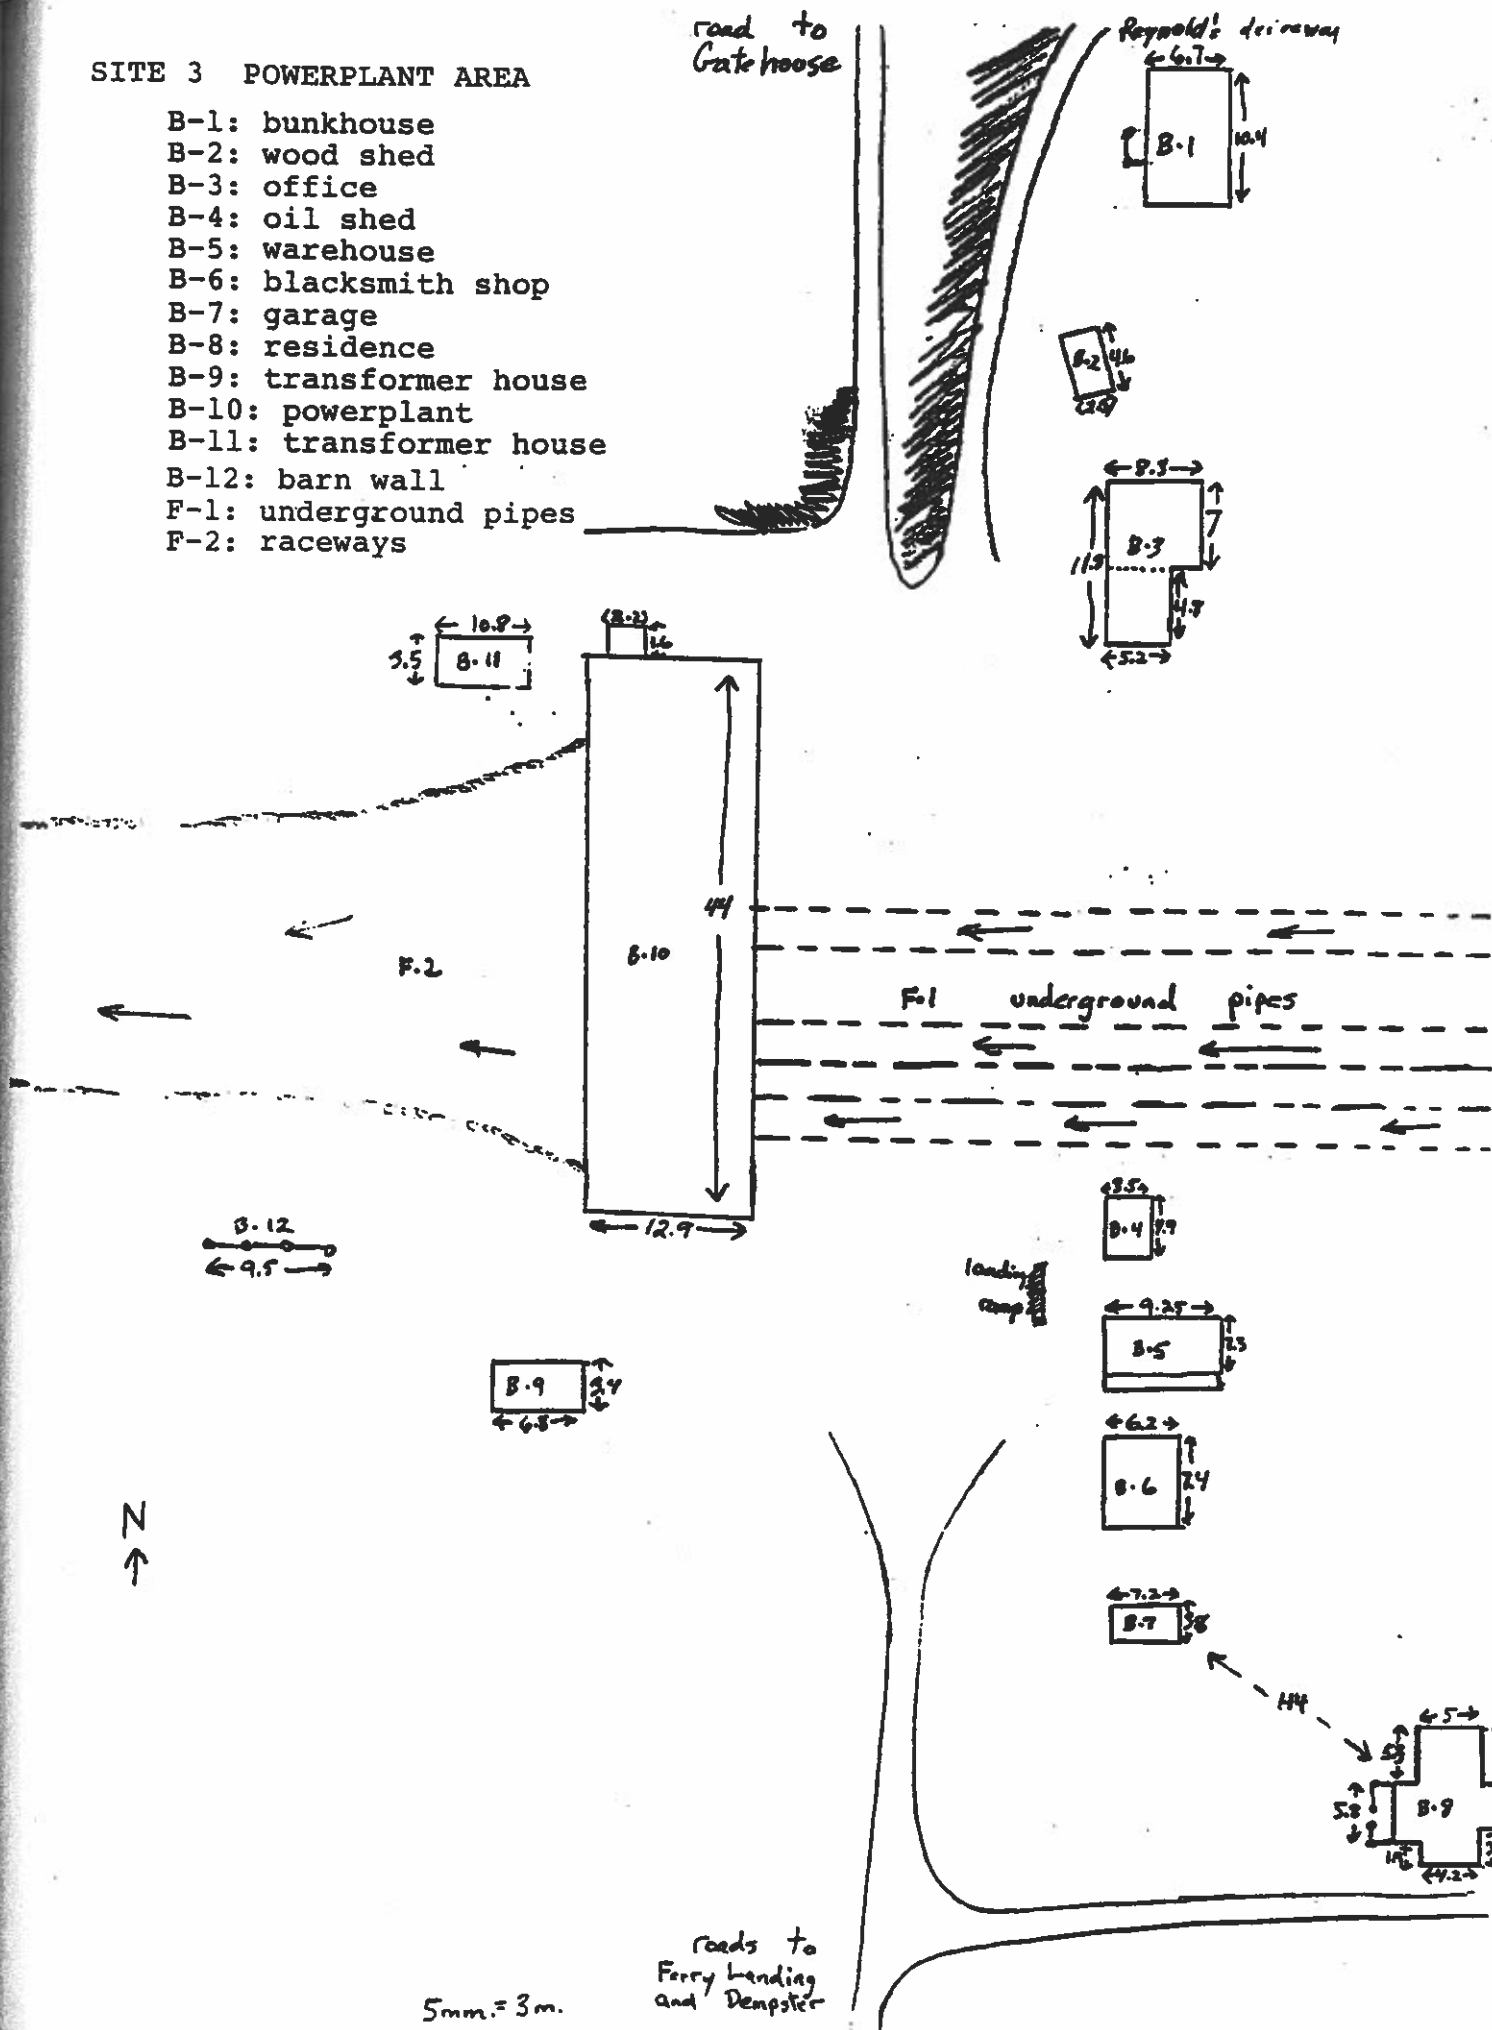
SITE 3 POWERPLANT AREA

- B-1: bunkhouse
- B-2: wood shed
- B-3: office
- B-4: oil shed
- B-5: warehouse
- B-6: blacksmith shop
- B-7: garage
- B-8: residence
- B-9: transformer house
- B-10: powerplant
- B-11: transformer house
- B-12: barn wall
- F-1: underground pipes
- F-2: raceways

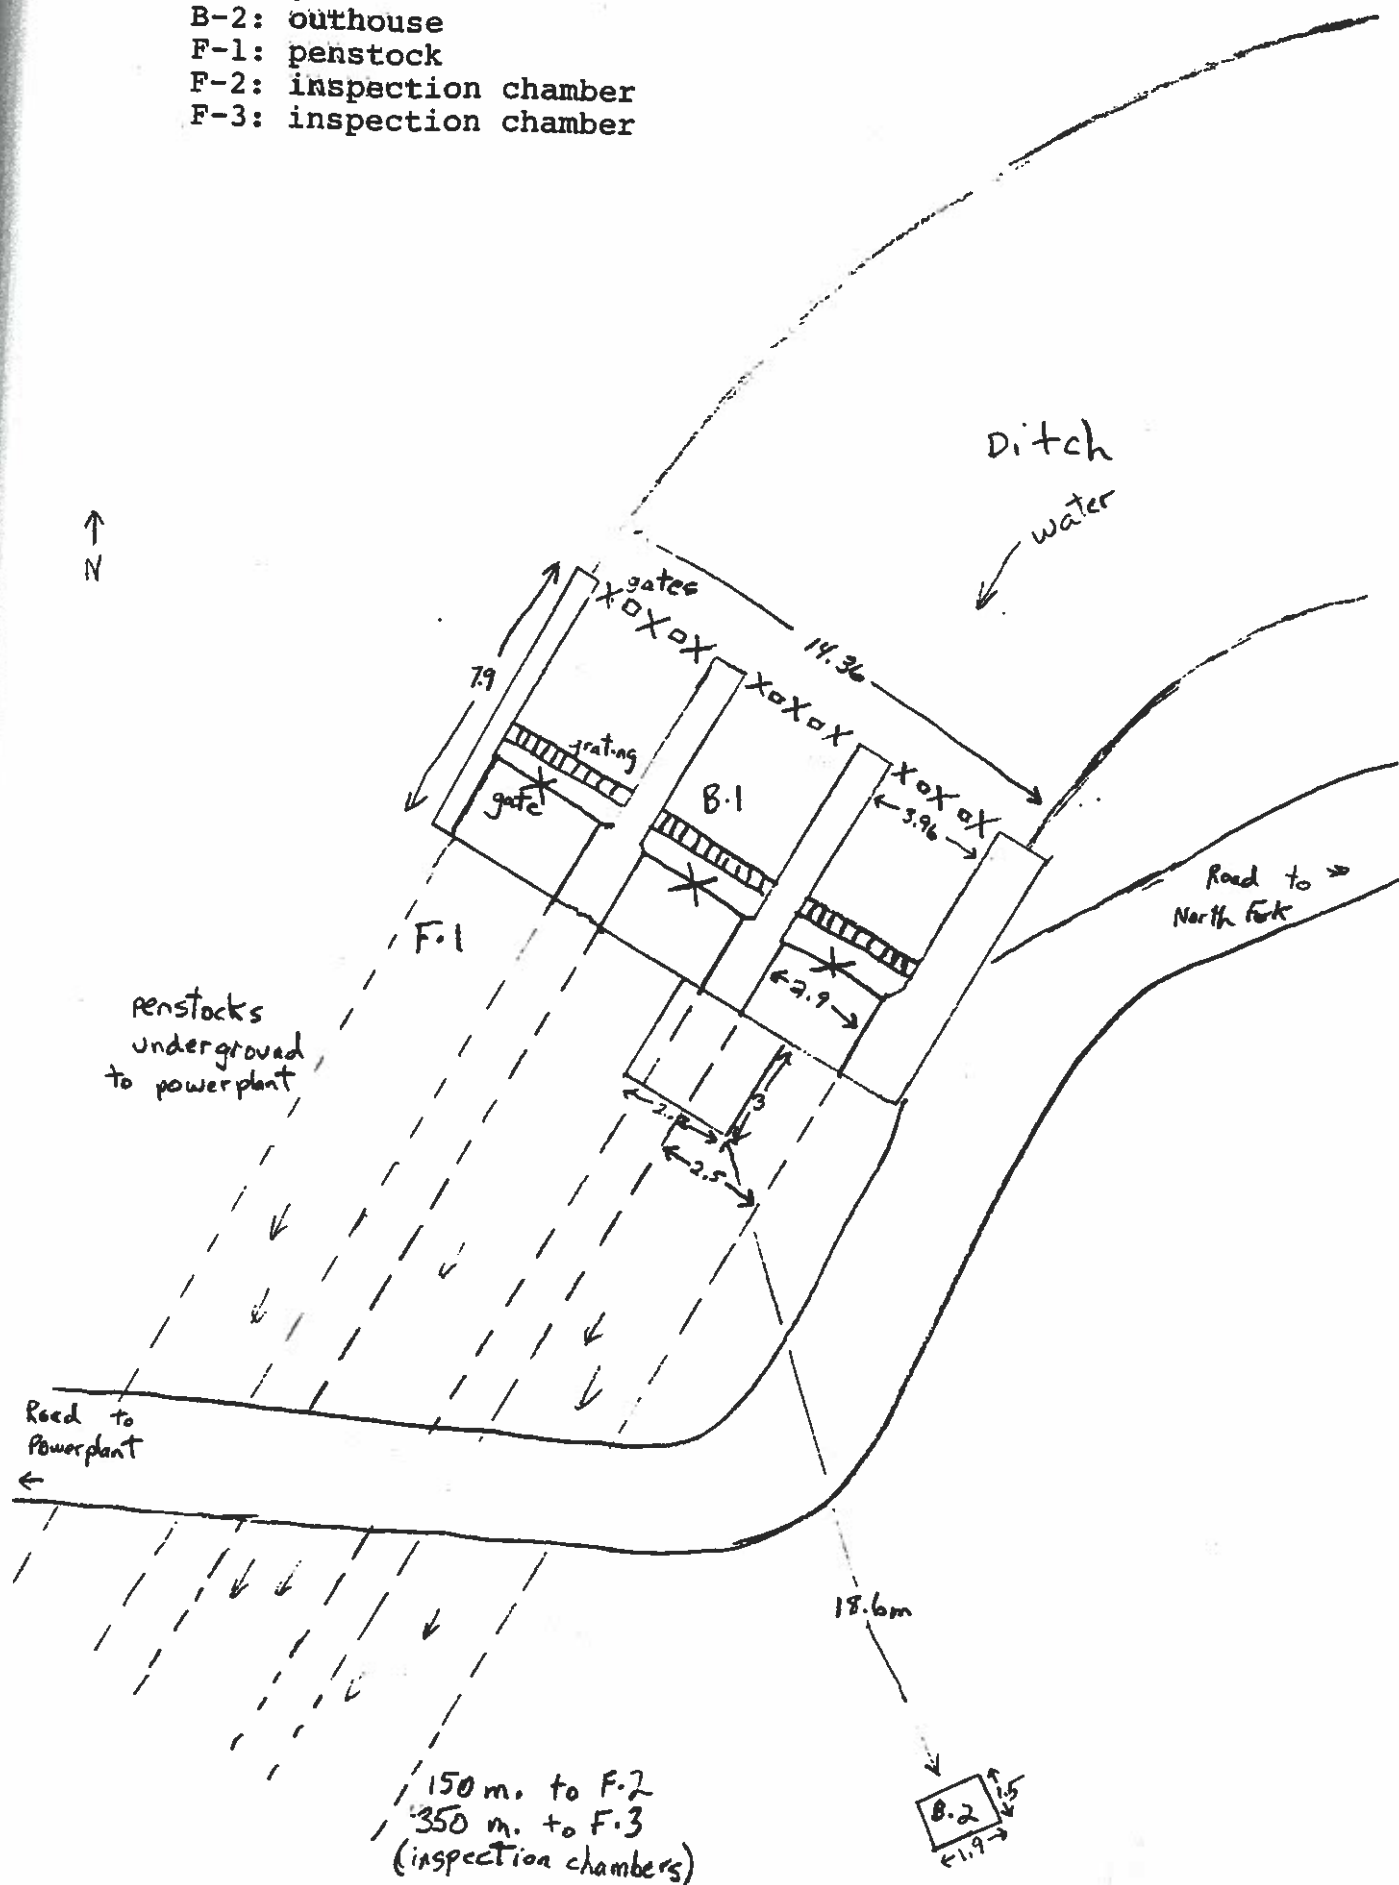
SITE 4 GATEHOUSE

Feature One: penstock and pipeline. Fair Condition. Some distortion in pipe from weight of earth covering the pipe. Used to transport water from the ditch system to the power plant.

Feature Two: inspection chamber number one. Good Condition. Area underground shored up. Used to inspect joints of pipe and execute repairs if necessary.

Feature Three: inspection chamber number two. Fair Condition. Open cut showing inspection chamber. Artifacts recorded; two large steel pipes running from the gatehouse to the power plant. Another single pipe 4.4 meters north of the double pipes also runs from the gatehouse to the power plant. Supplies the turbines with water from the North Fork Ditch system.

- B-1: gatehouse
- B-2: outhouse
- F-1: penstock
- F-2: inspection chamber
- F-3: inspection chamber

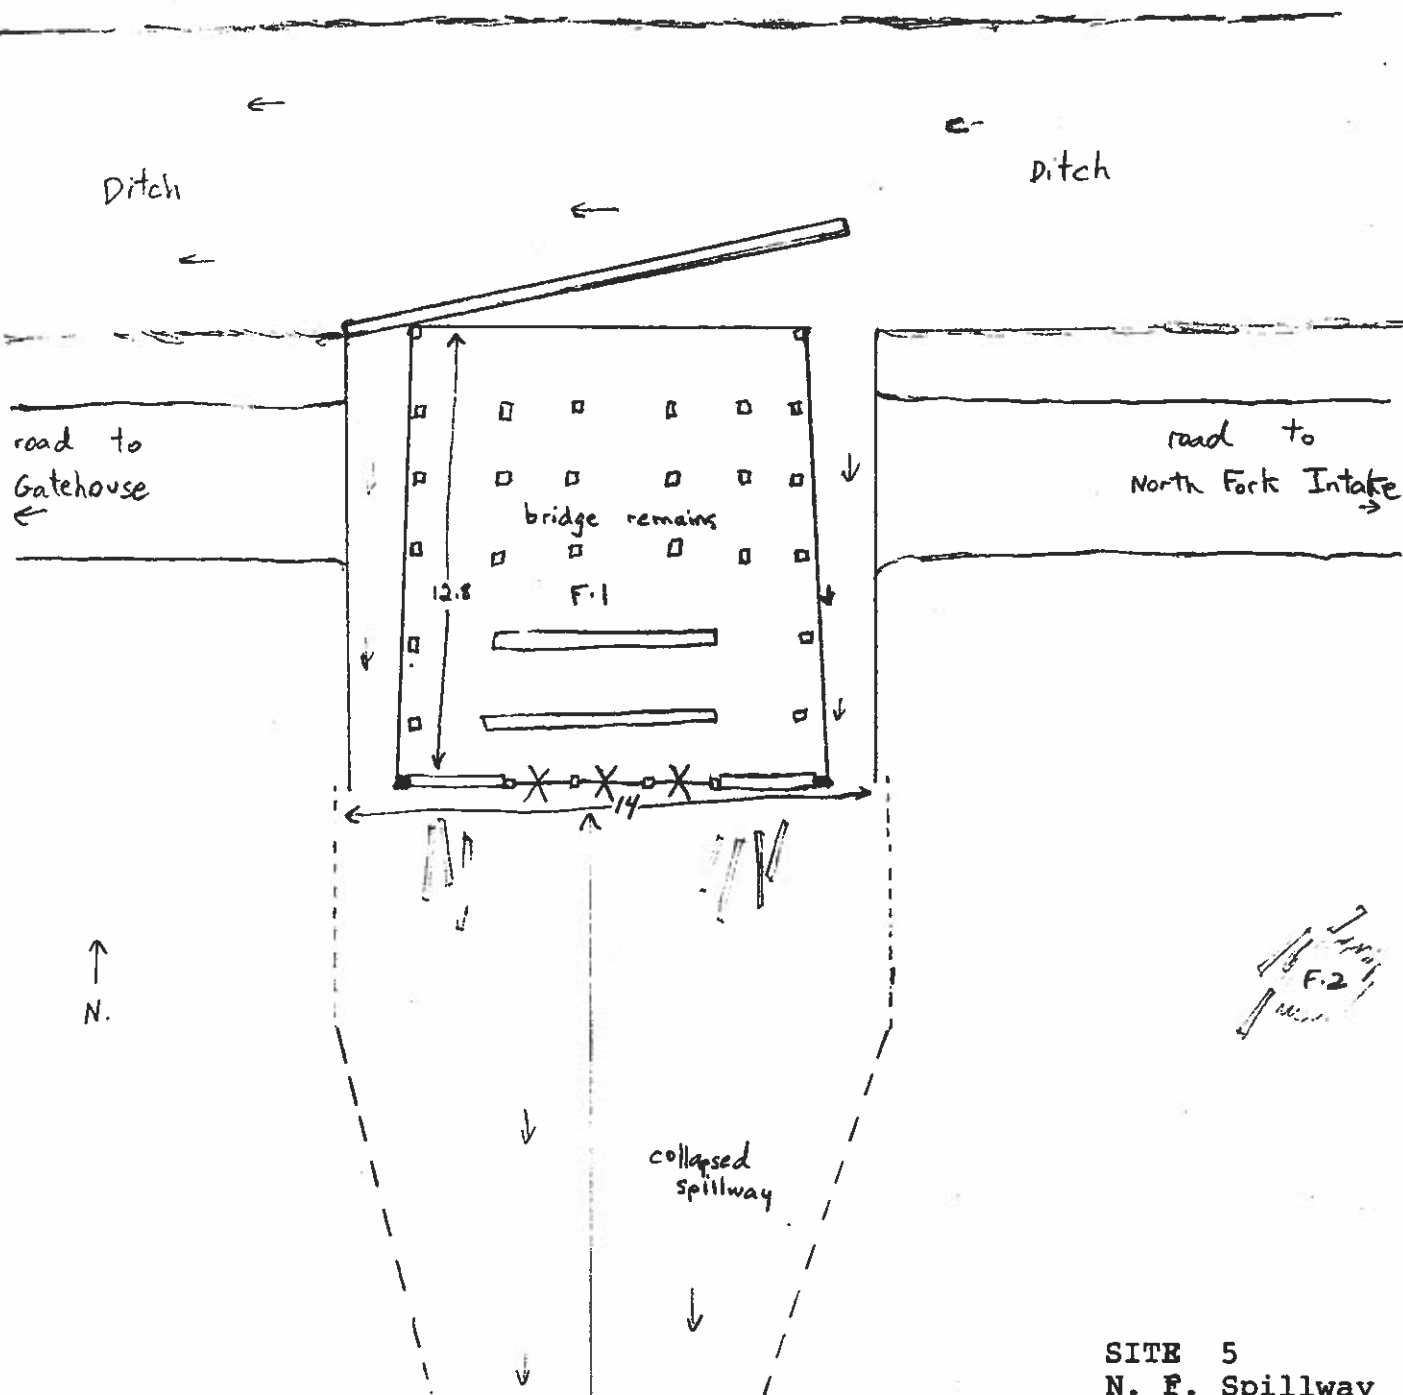
SITE 5
N. F. Spillway

Feature One: diversion for ditch. Fair Condition. Used to help control the amount of water in the ditch system.

Feature Two: sawmill. Poor Condition. Roads and mounds of sawdust indicate the location of the mill. Lumber was used for the company's various projects.

F-1: diversion
F-2: sawmill site

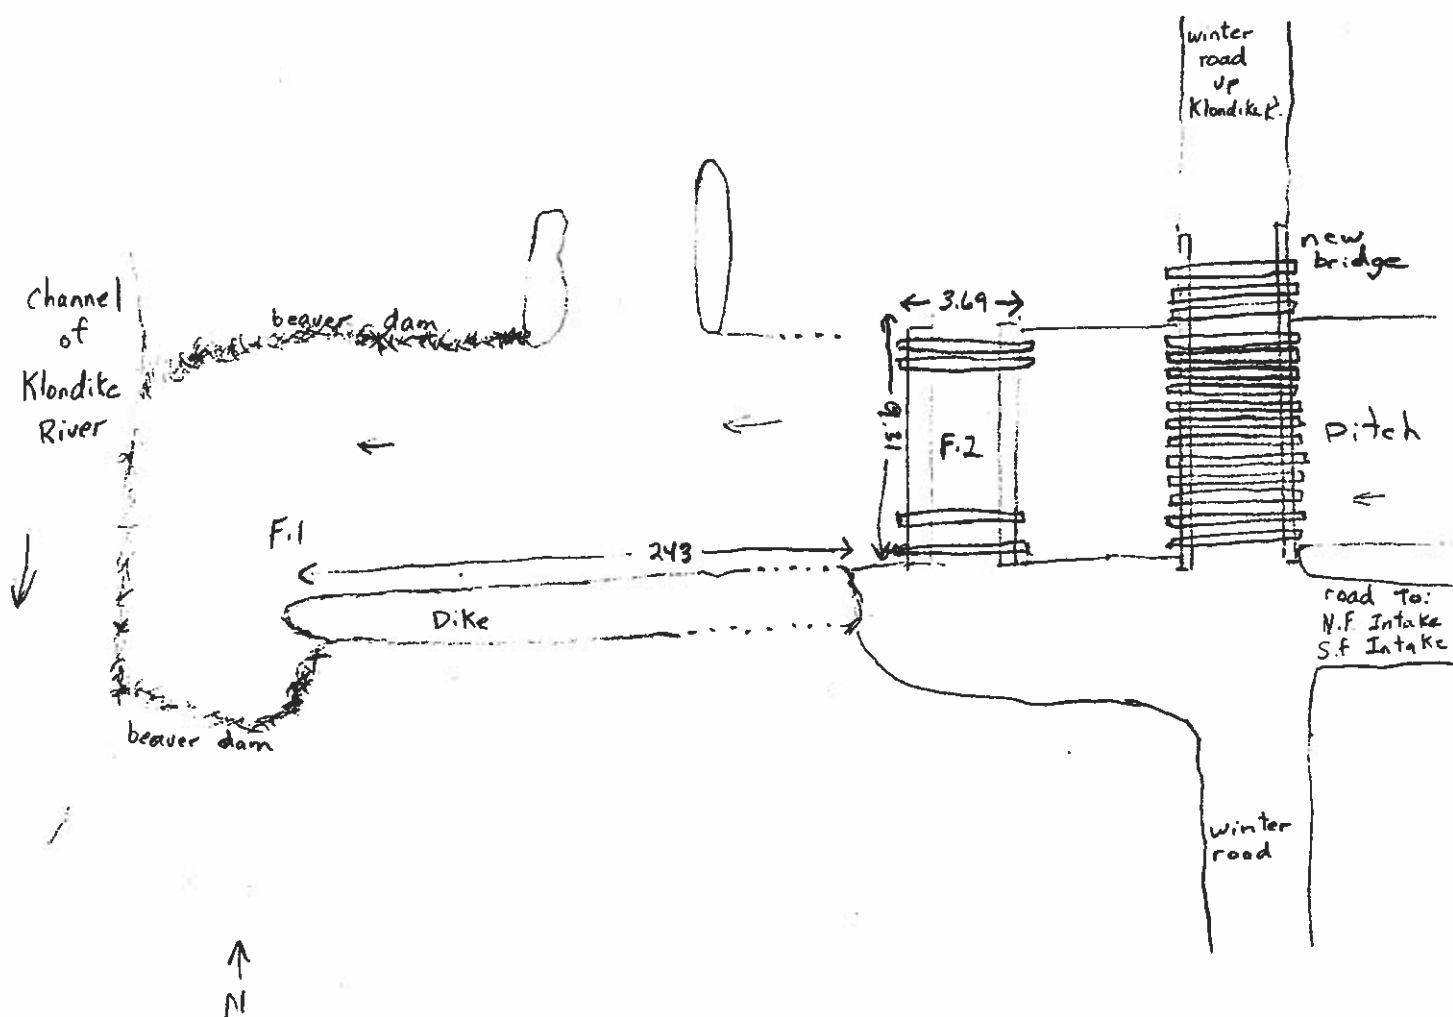
SITE 7 SOUTH FORK DISCHARGE AND BRIDGE

Feature One: discharge of South Fork Ditch. Poor Condition. Ditching and diking was constructed to conduct water from the South Fork of the Klondike River to this entrance point above the North Fork Ditch Intake.

Feature Two: bridge, timber and plank. Poor Condition. Used to provide access to other side of South Fork Ditch for travel further north up the North Klondike River.

F-1: discharge of South Fork ditch
 F-2: bridge

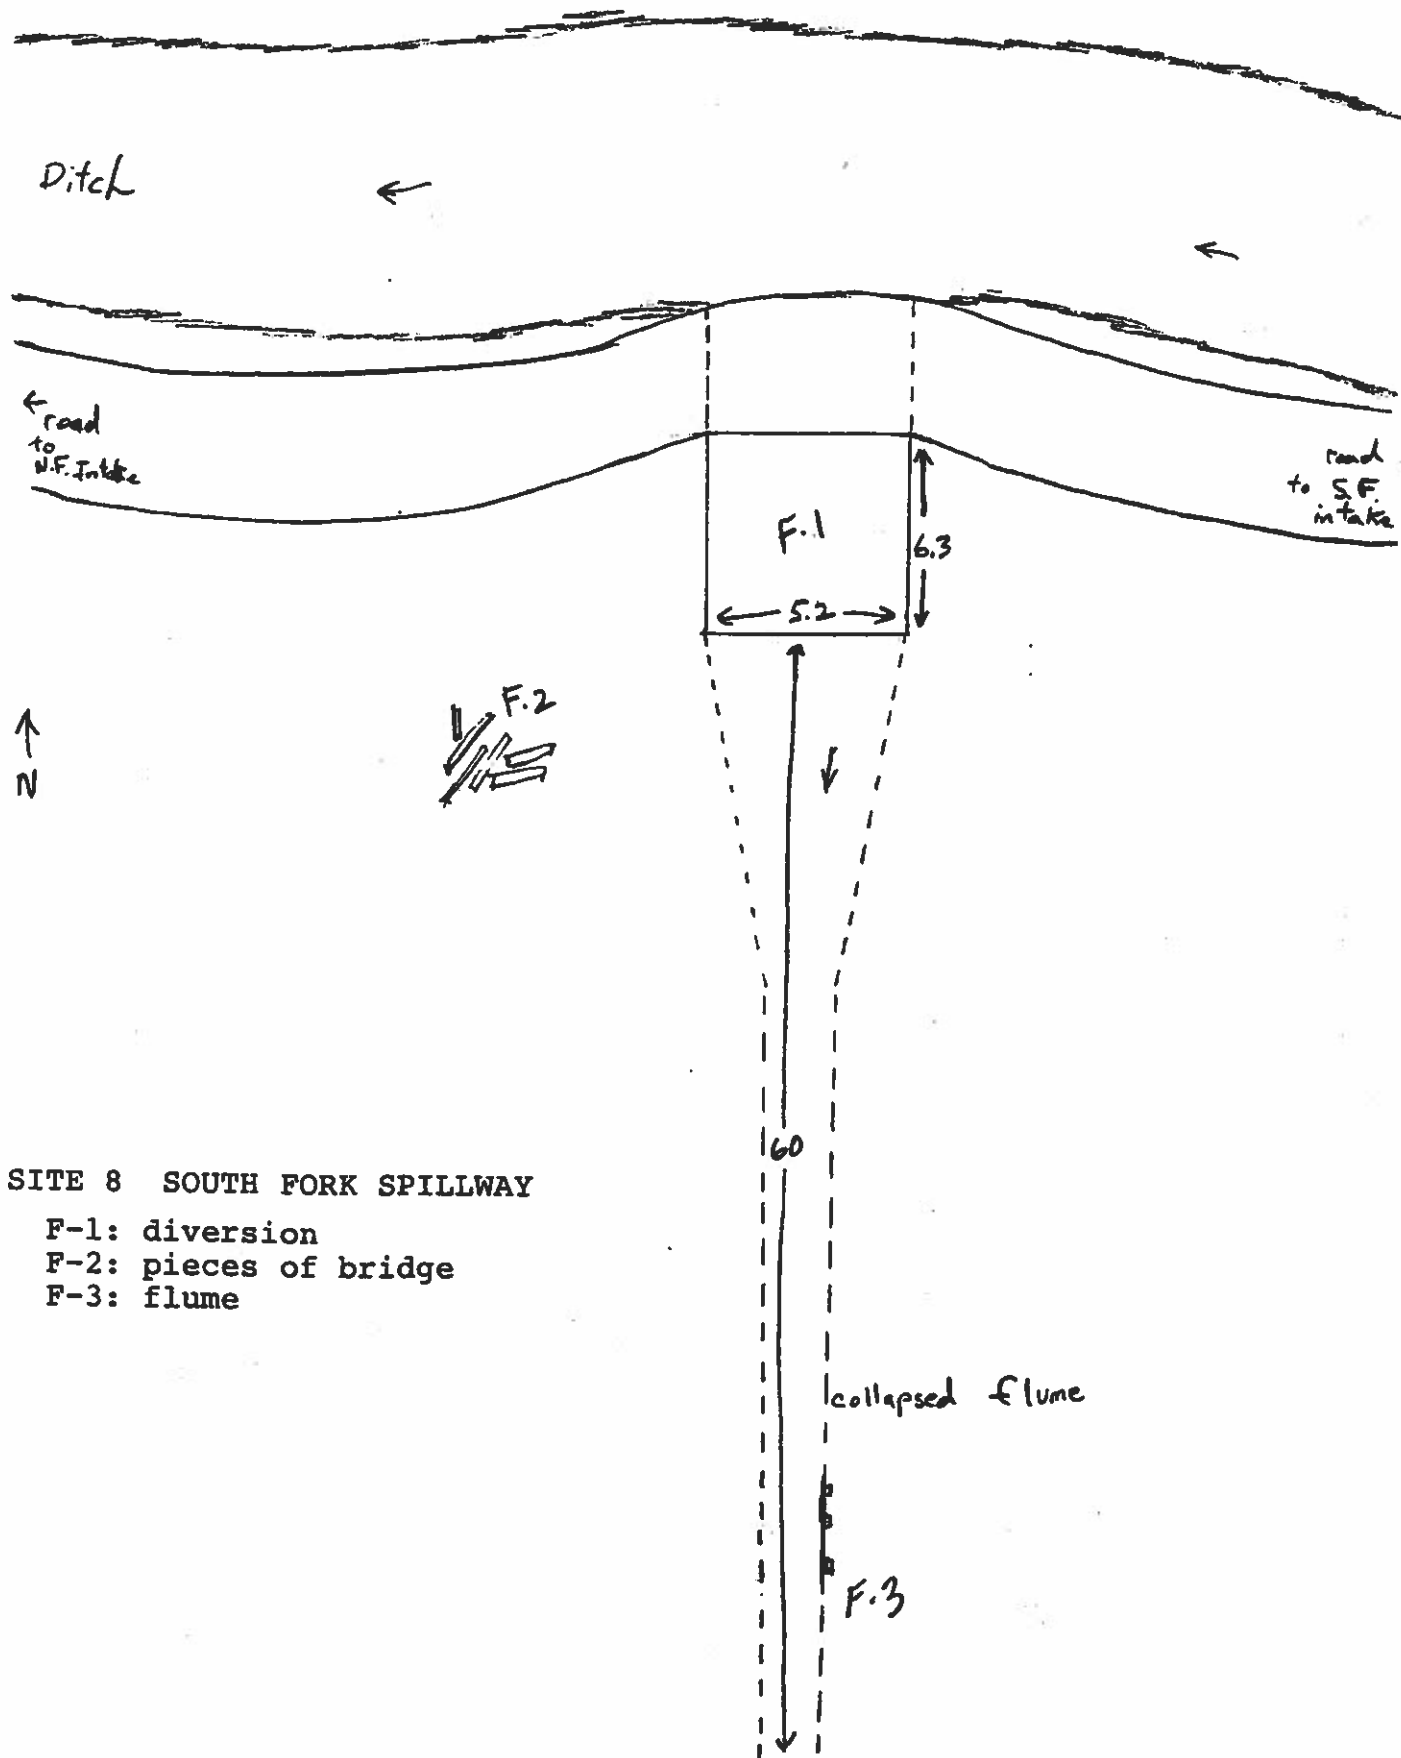
SITE 8 SOUTH FORK SPILLWAY

Feature One: diversion or spillway, timber and plank. Poor Condition. Used to control water levels in the South Fork Ditch by diverting water out.

Feature Two: flume, plank, board and batten. Poor condition. Used to carry water away from diversion.

Feature Three: bridge remains, timber and plank. Poor Condition. Bridge allowed traffic to move over diversion. Has been pushed out of the way for contemporary road construction.

F-1: diversion

F-3: flume

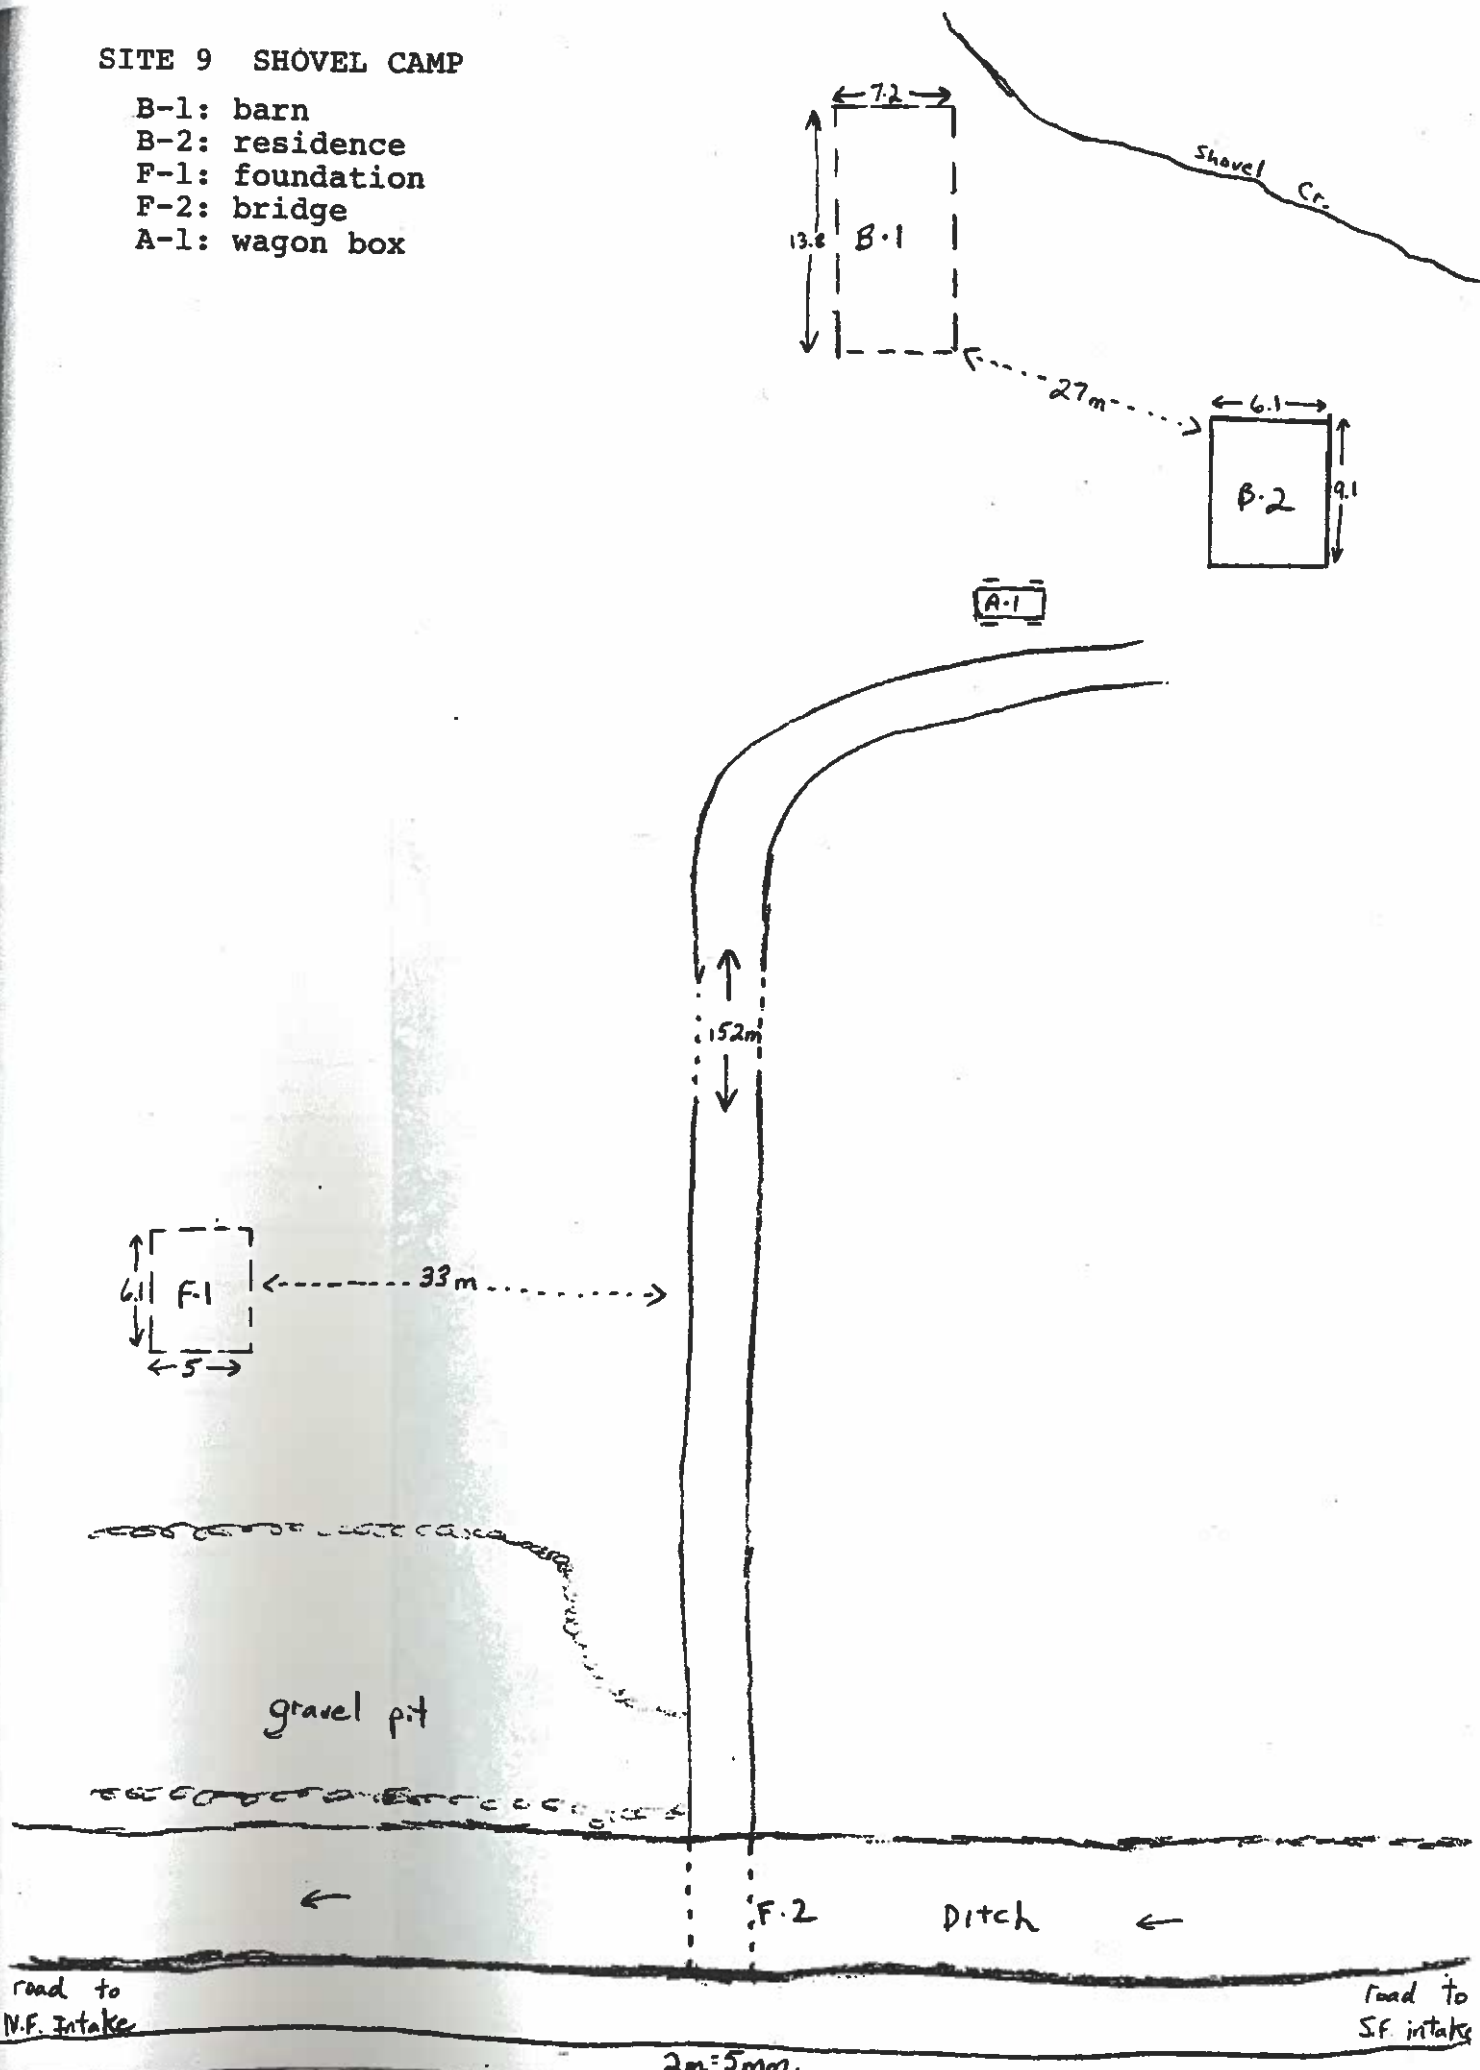
SITE 9 SHOVEL CAMP

Building One: barn, log, collapsed roof. Poor Condition. Artifacts recorded, barrel stove, gasoline cans, crates, bed frame, bed springs.

Building Two: residence, log cabin. Good Condition. Used as housing for YCGC employees.

Feature One: foundation with root cellar, log. Poor Condition. The building that was here was moved to the North Fork Intake Camp. Artifacts recorded; ladder, grinding wheel frame, crates, tin cans.

Feature Two: bridge, timber and plank. Poor Condition, collapsed. Used to cross the South Fork Ditch.

Artifact One: wagon box, frame. Poor Condition. Used for freighting.

- B-1: barn
- B-2: residence
- F-1: foundation
- F-2: bridge
- A-1: wagon box
