**PRELIMINARY SURVEY AND FIELD RECORDING
NORTH FORK POWER PROJECT**

DAWSON CITY MUSEUM AND HISTORICAL SOCIETY

**Barbara Hogan and Gregory Skuce
August 1992**

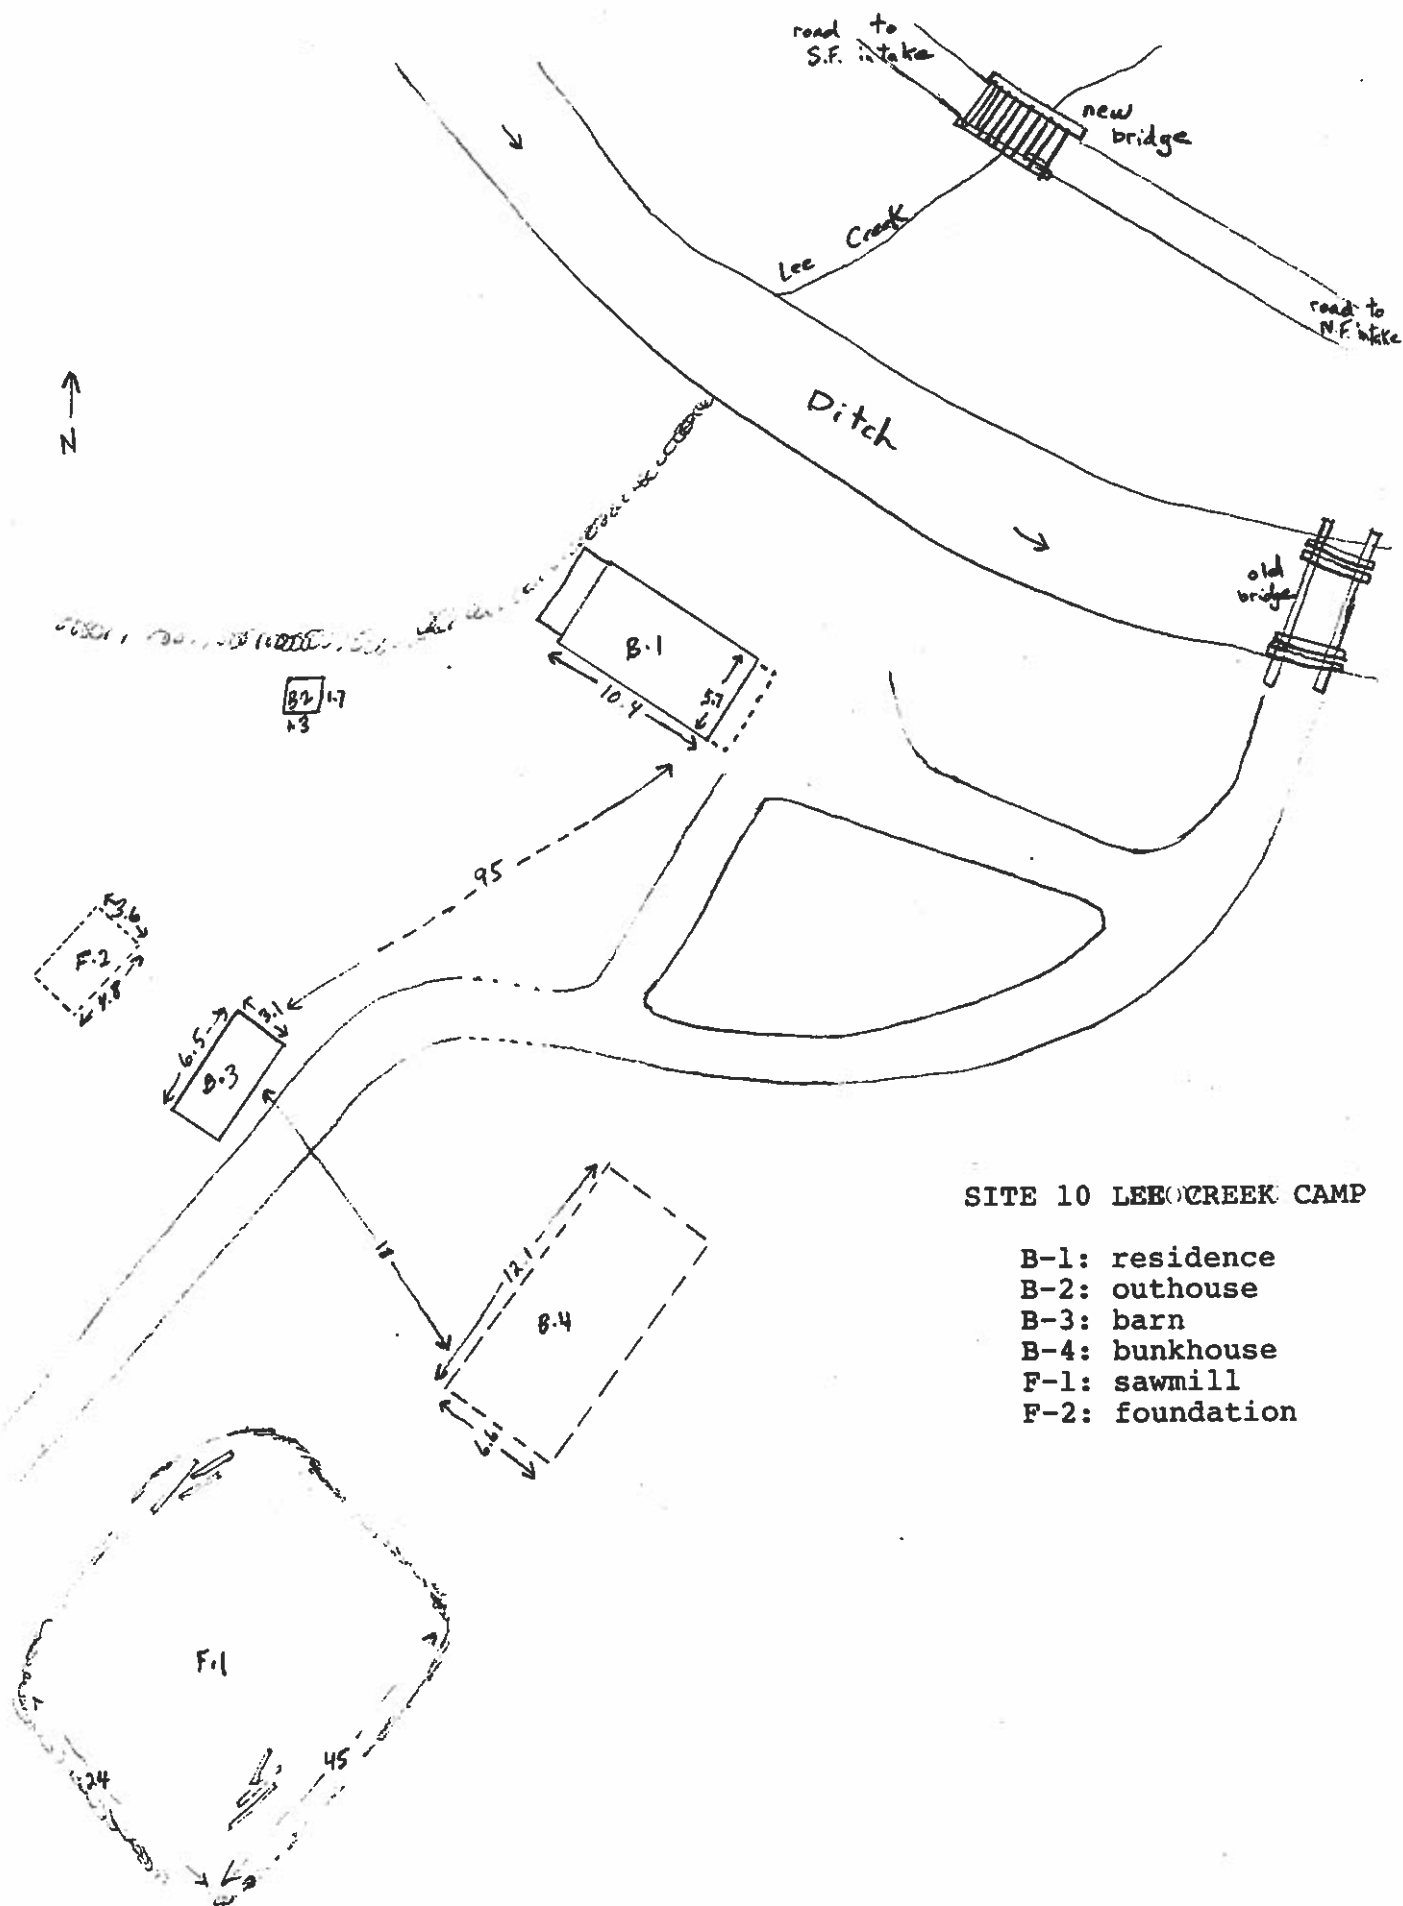
SITE 10 LEE CREEK CAMP

Building One: residence, log with pole, sod, and tin roof. Good Condition. housing for gatekeeper and ditch maintenance personnel.

Building Two: outhouse, plank with slab battens. Poor Condition.

Building Three: barn/garage, plank and slab. Poor Condition. Artifacts recorded; singletrees, wrenches, wagon sides, gas tanks, stoves.

Building Four: bunkhouse, only sill logs remain. Poor Condition.

Feature One: sawmill, large mound of sawdust. Poor Condition. Artifacts recorded; planks, cans, bed frames, timbers and blocking.

Feature Two: foundation, sill log left. Poor Condition.

- B-1: residence
- B-2: outhouse
- B-3: barn
- B-4: bunkhouse
- F-1: sawmill
- F-2: foundation

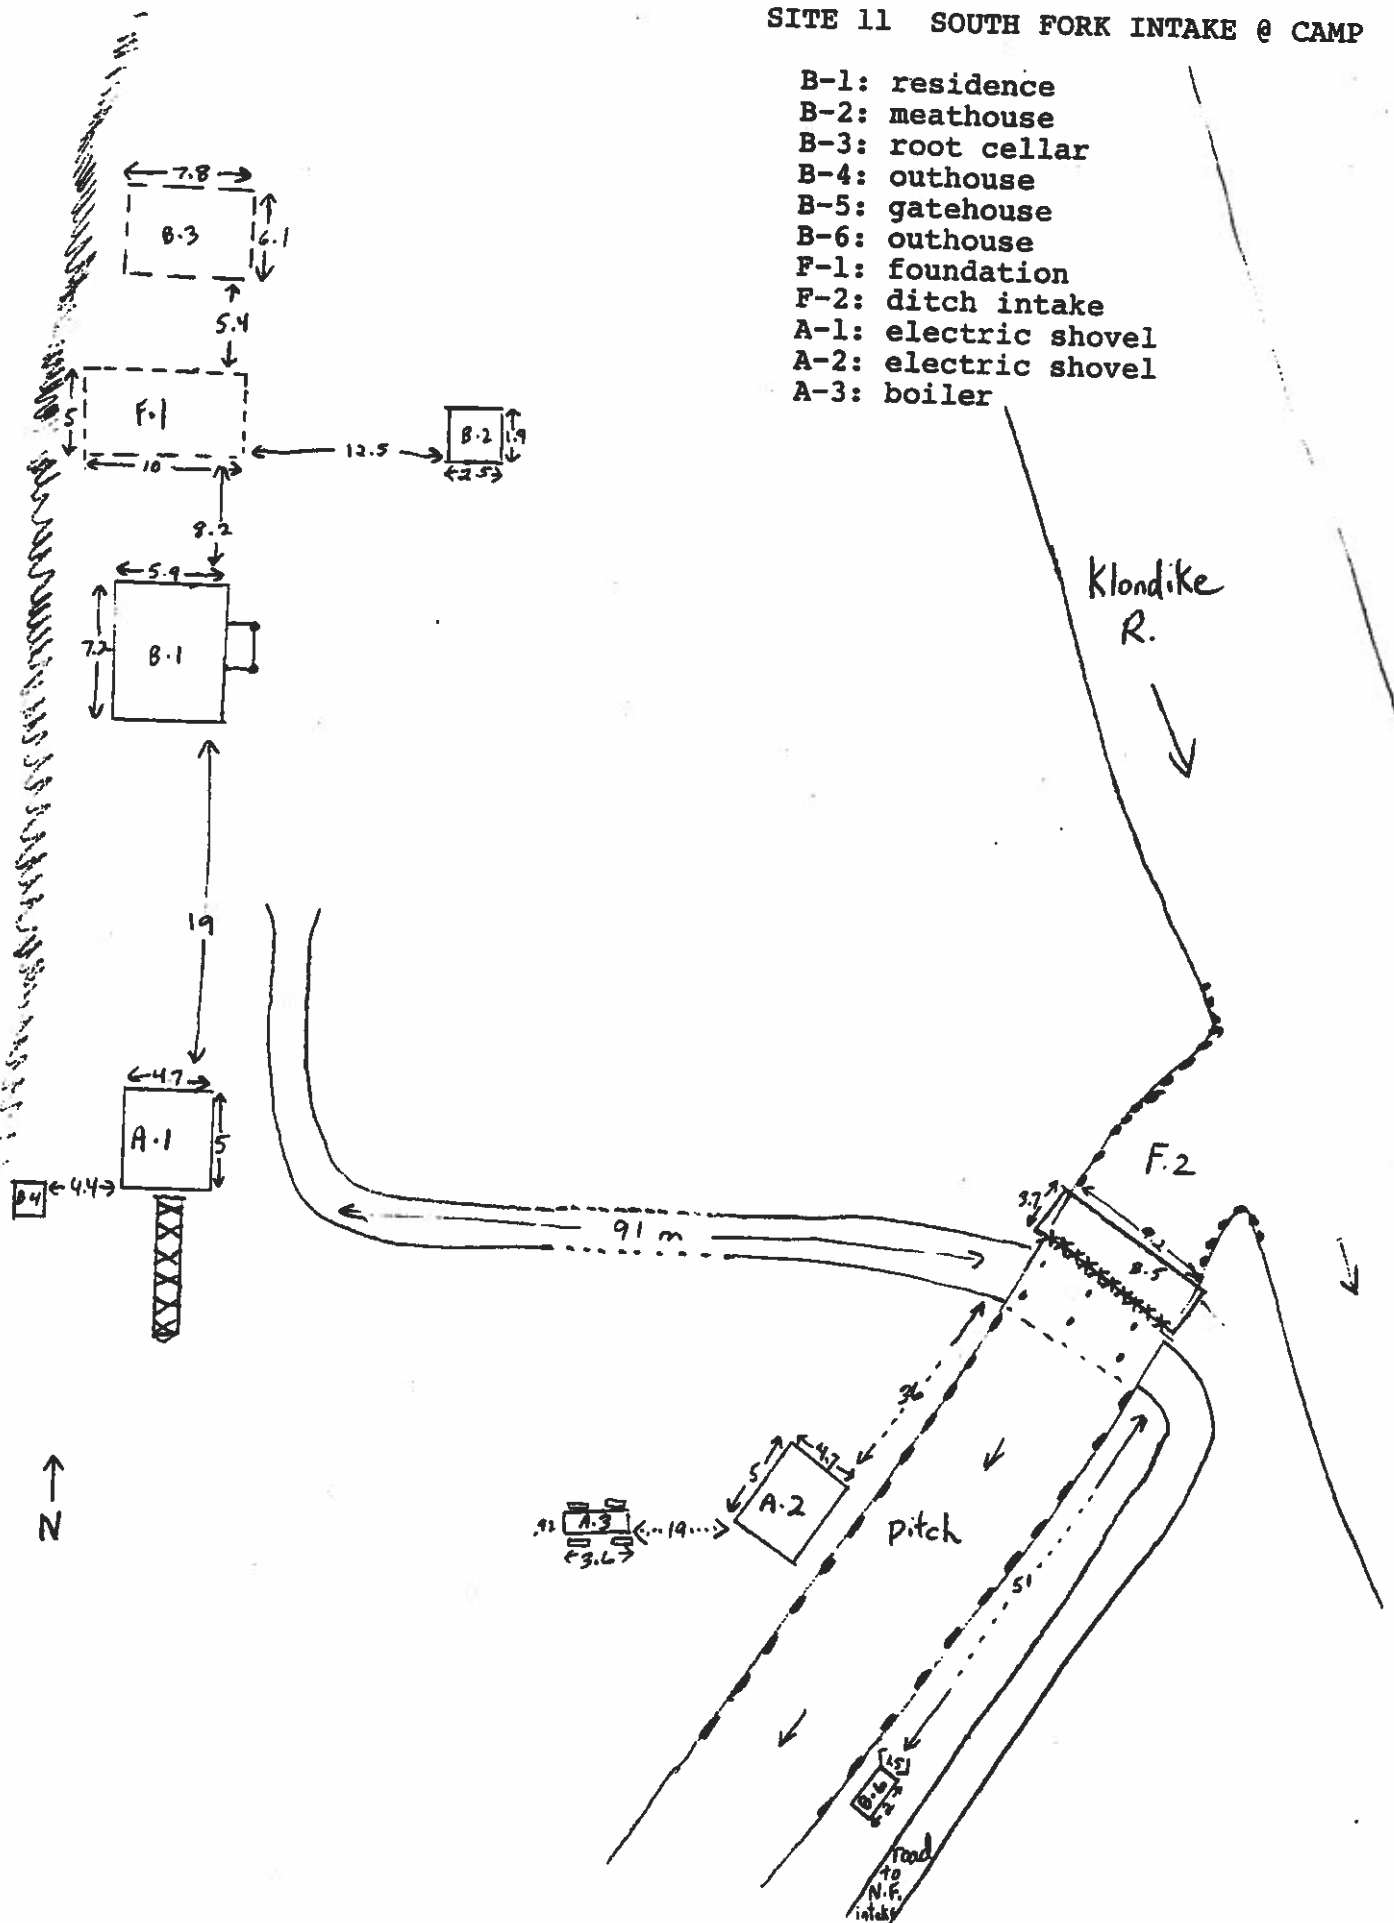
SITE 11 SOUTH FORK INTAKE @ CAMP

Building One: residence, log with pole, dirt and tin roof. Good Condition. Used as gatekeepers house.

Building Five: gatehouse, frame, post and beam. Good Condition. Used to cover a series of six gates for maintaining amount of water entering the ditch from the South Fork of the Klondike River. Artifacts recorded; electric heaters.

Feature Two: South Fork Intake, excavated channel. Good Condition. Made to direct water from the South Fork of the Klondike River into the gatehouse.

Artifact One: electric shovel, manufactured by Marion Mfg. Co. Good Condition. Used to excavate the South Fork Ditch.

Artifact Two: electric shovel, , Marion Mfg. Co. Poor Condition. Has no boom - may have been used for parts for other shovels.

Artifact Three: boiler on wheels, Watrous Engine Works. Good Condition. Used for thawing around gatehouse and canal.

- B-1: residence
- B-2: meathouse
- B-3: root cellar
- B-4: outhouse
- B-5: gatehouse
- B-6: outhouse
- F-1: foundation
- F-2: ditch intake
- A-1: electric shovel
- A-2: electric shovel
- A-3: boiler

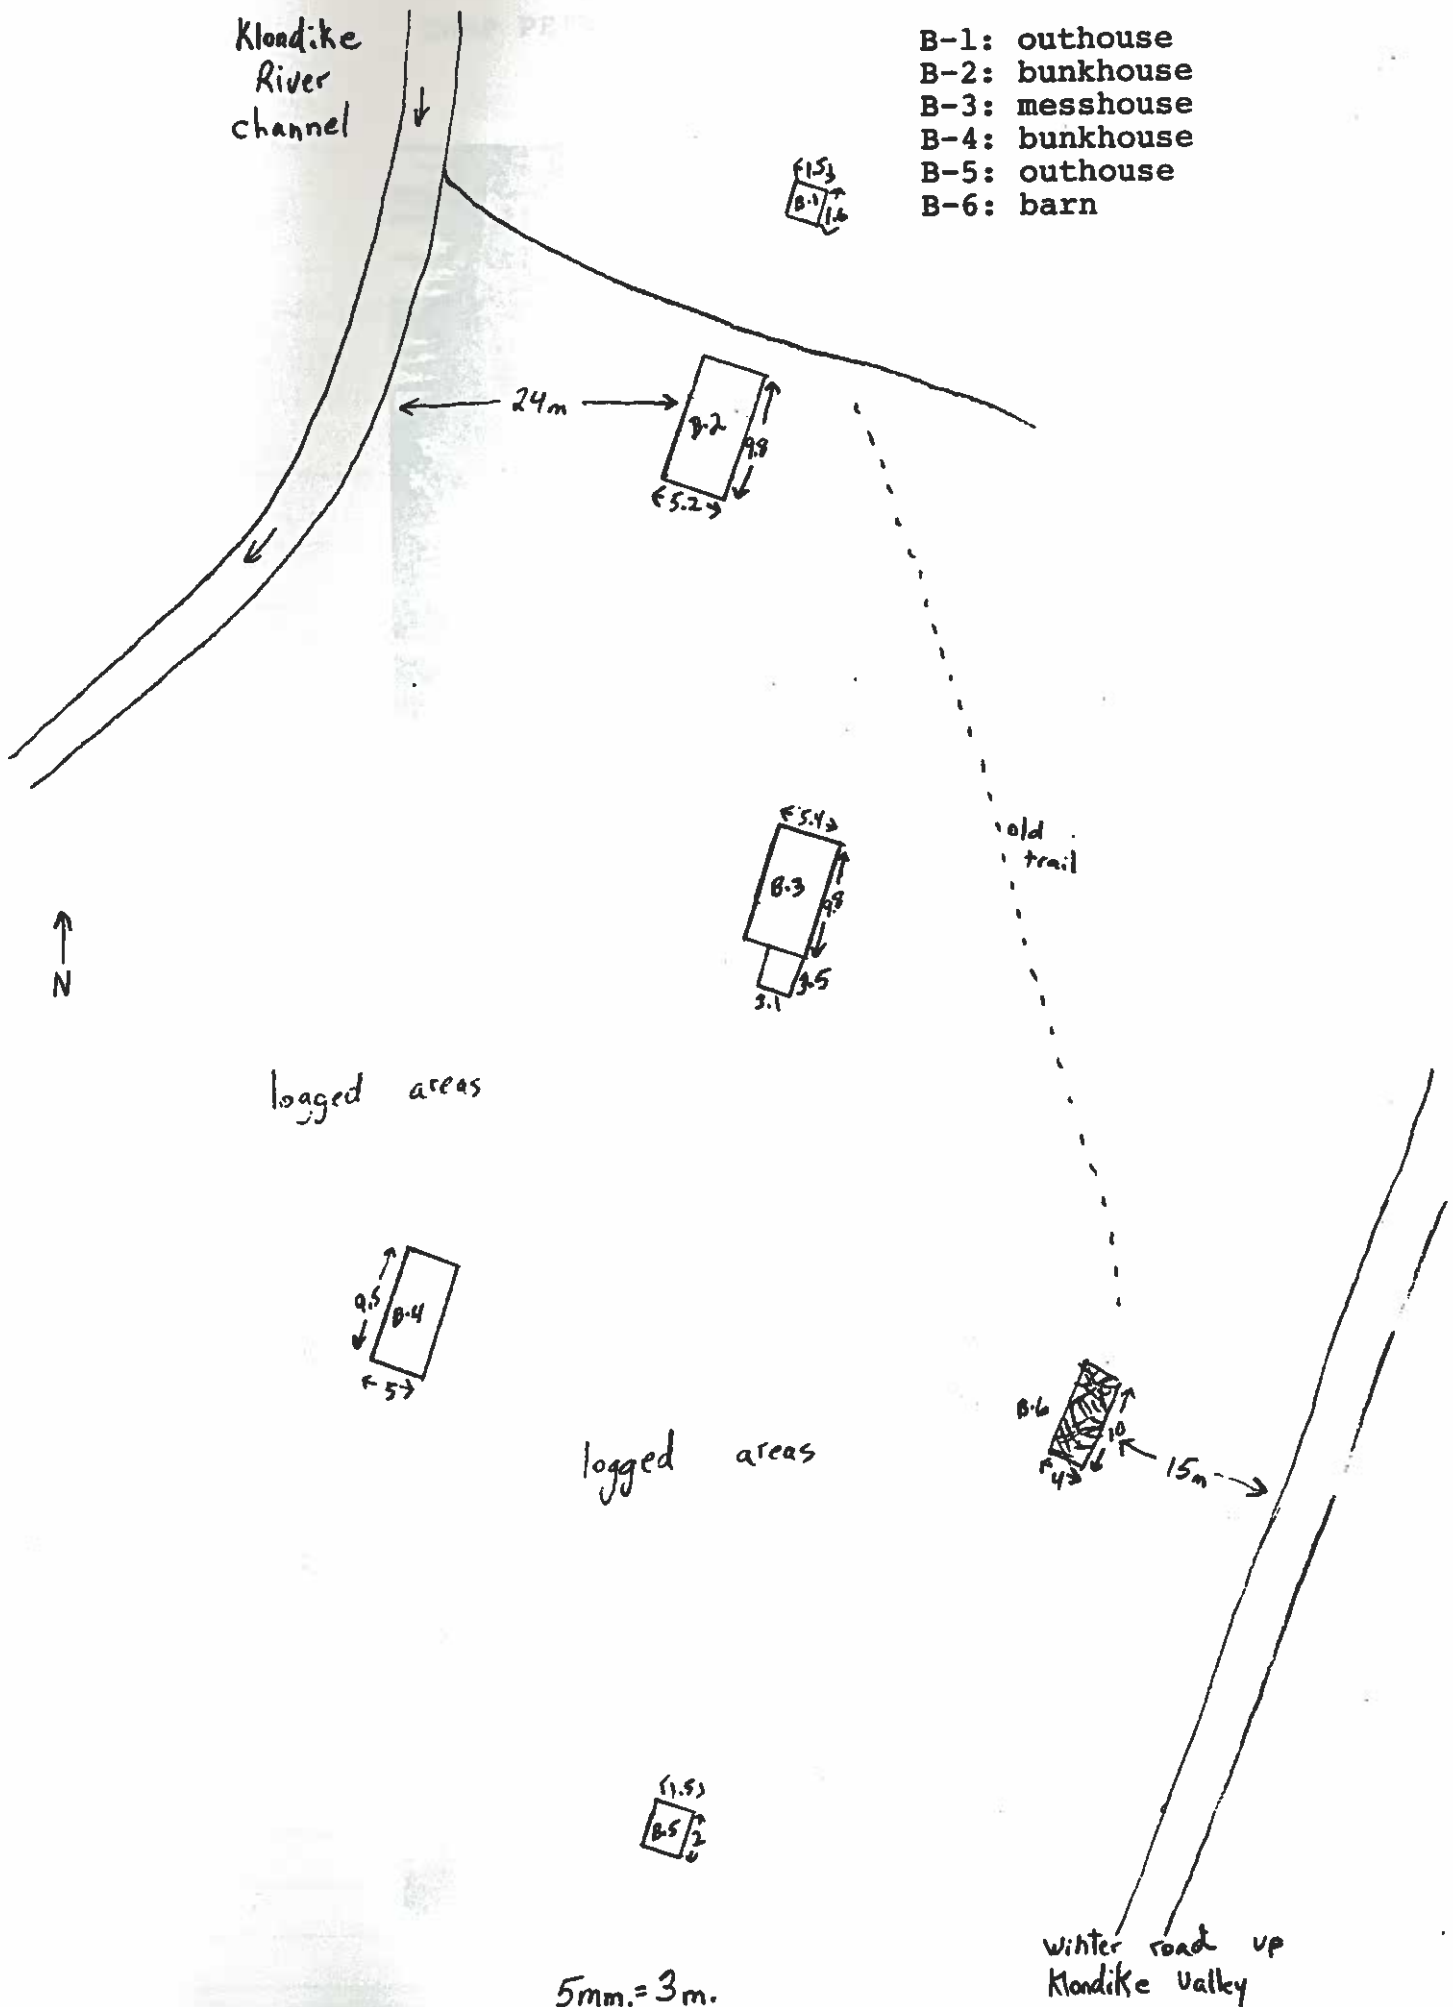
SITE 12 CAMP PETROGRAD

Building Two: bunkhouse, log with collapsed sod and plank roof. Poor Condition. Artifacts recorded; barrel stove, cookstove, beds, tables, shelves, handmade door.

Building Three: messhouse, log, collapsed pole and sod roof. Poor Condition.

Building Four: bunkhouse, log, collapsed pole and sod roof. Poor Condition. Evidence of bunkbeds indicate use as a bunkhouse.

Building Five: outhouse, plank. Fair Condition.

Building Six: barn, log, collapsed. Poor Condition. Building has been driven over by a bulldozer

- B-1: outhouse
- B-2: bunkhouse
- B-3: messhouse
- B-4: bunkhouse
- B-5: outhouse
- B-6: barn

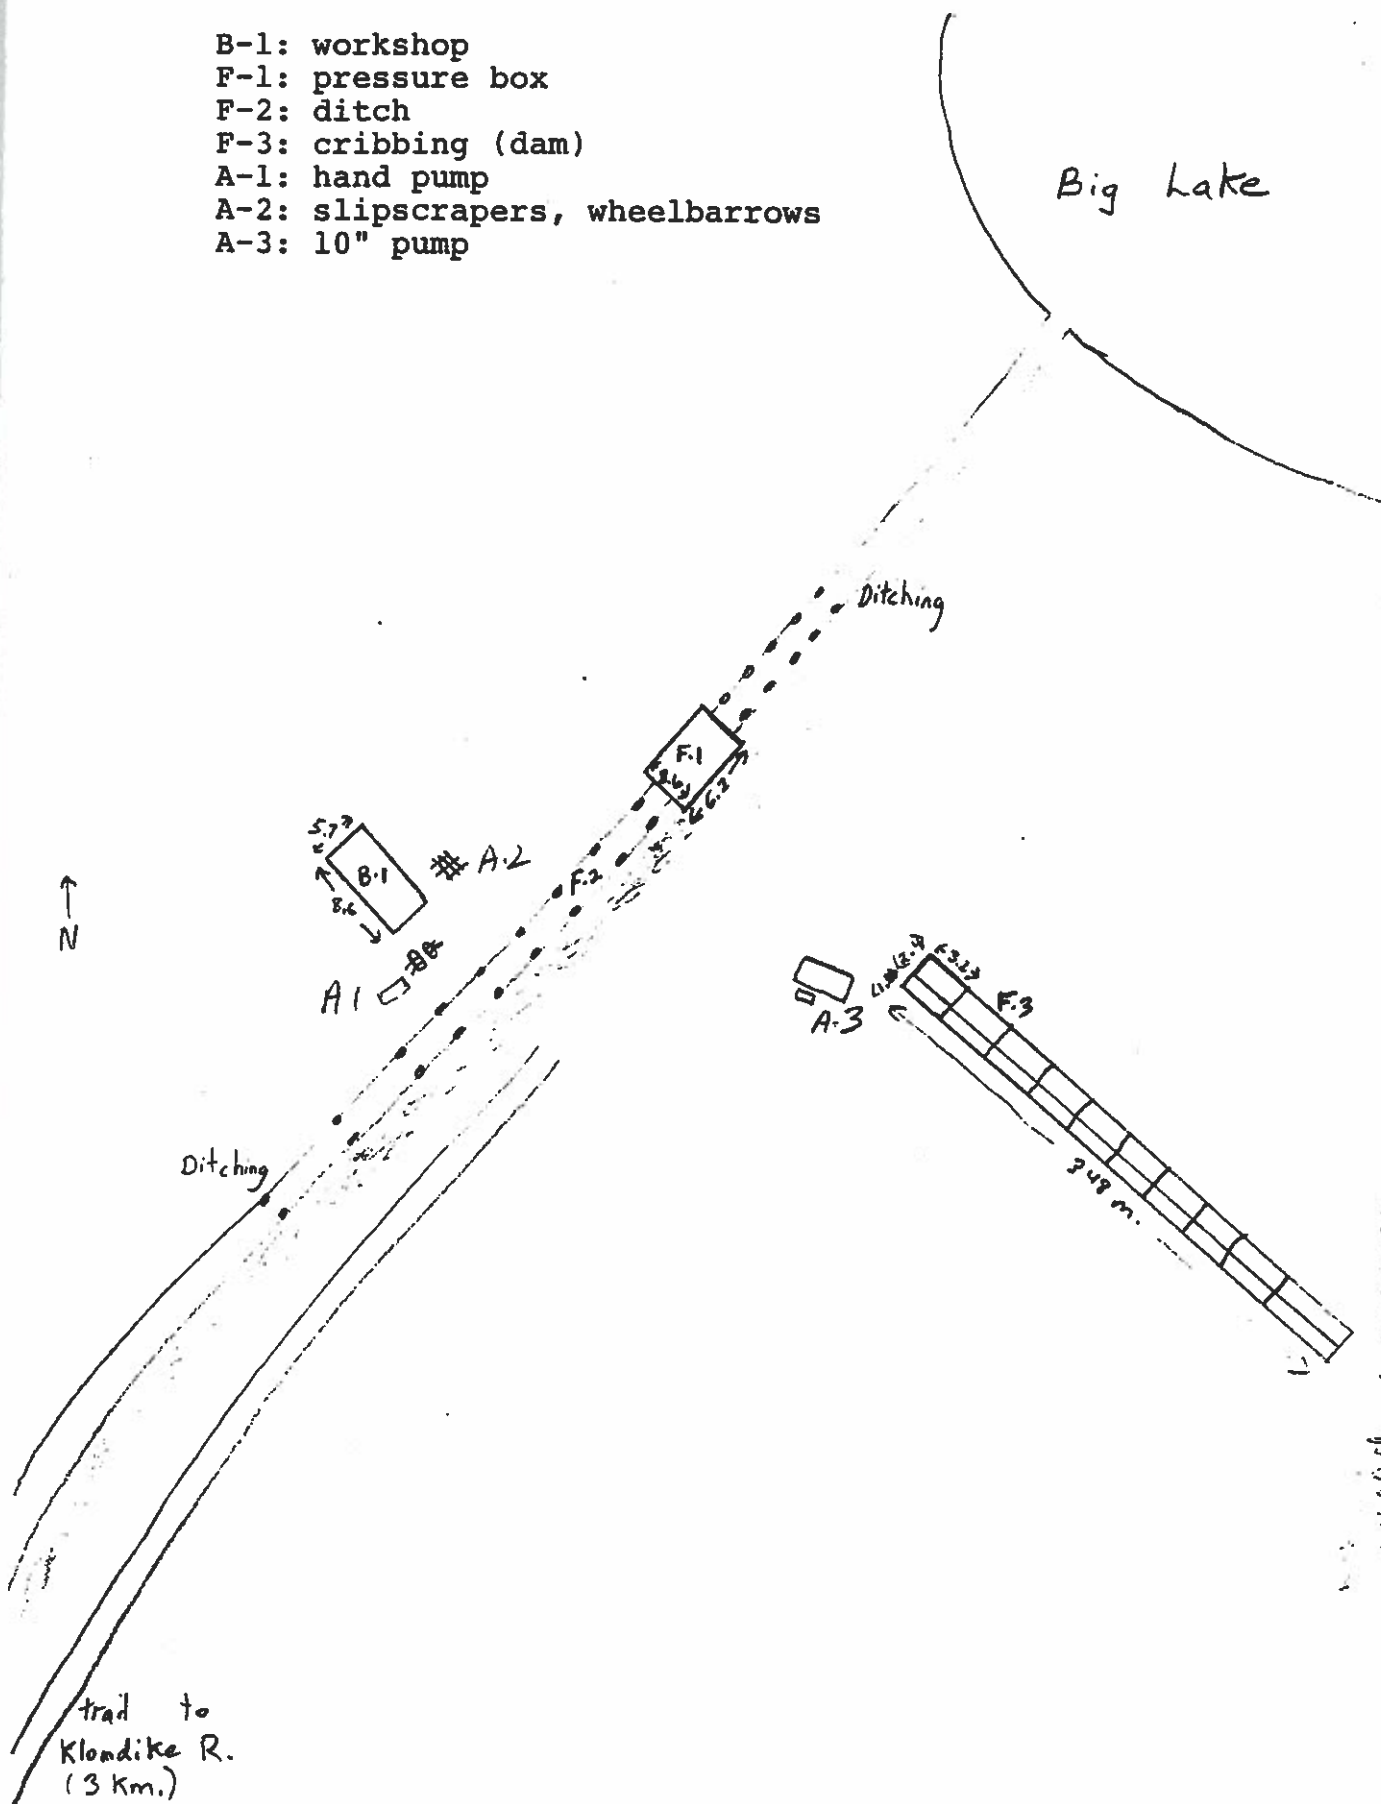
SITE 13 MISHENKO POWER PROJECT (proposed)

Building One: workshop/storage, rough sawn slabs. Poor Condition. Collapsed roof.

Feature One: pressure box, squared timbers and plank. Good Condition. Was intended to be used in conjunction with unfinished dam to direct water in the reservoir to a pipeline for a power plant. Artifacts recorded; stove, blocking, gasoline cans, nail cans, boards.

Feature Two: ditch dug by steam shovel and by hand. Fair Condition. Intended for channelling water away from proposed dam.

Feature Three: cribbing for proposed dam, saddle notched logs. Good Condition. Likely the base of the dam- cribbing would have been filled with rocks and covered with earth for extra strength.

Artifact One: hand operated pump, Gould's Manufacturing Co. Seneca, New York. Good Condition.

Artifact Two: wheelbarrows and slip scrapers, hand operated and horse pulled. Good Condition. Used to move dirt, probably when digging the ditch.

Artifact Three: pump, Worthington Mfg. Co. Good Condition. No visible signs of wear.

- B-1: workshop
- F-1: pressure box
- F-2: ditch
- F-3: cribbing (dam)
- A-1: hand pump
- A-2: slipscrapers, wheelbarrows
- A-3: 10" pump
