YUKON DITCH

KLONDIKE SYPHON TO BONANZA CREEK

Preliminary Survey and Field Recording Project

Dawson City Museum and Historical Society

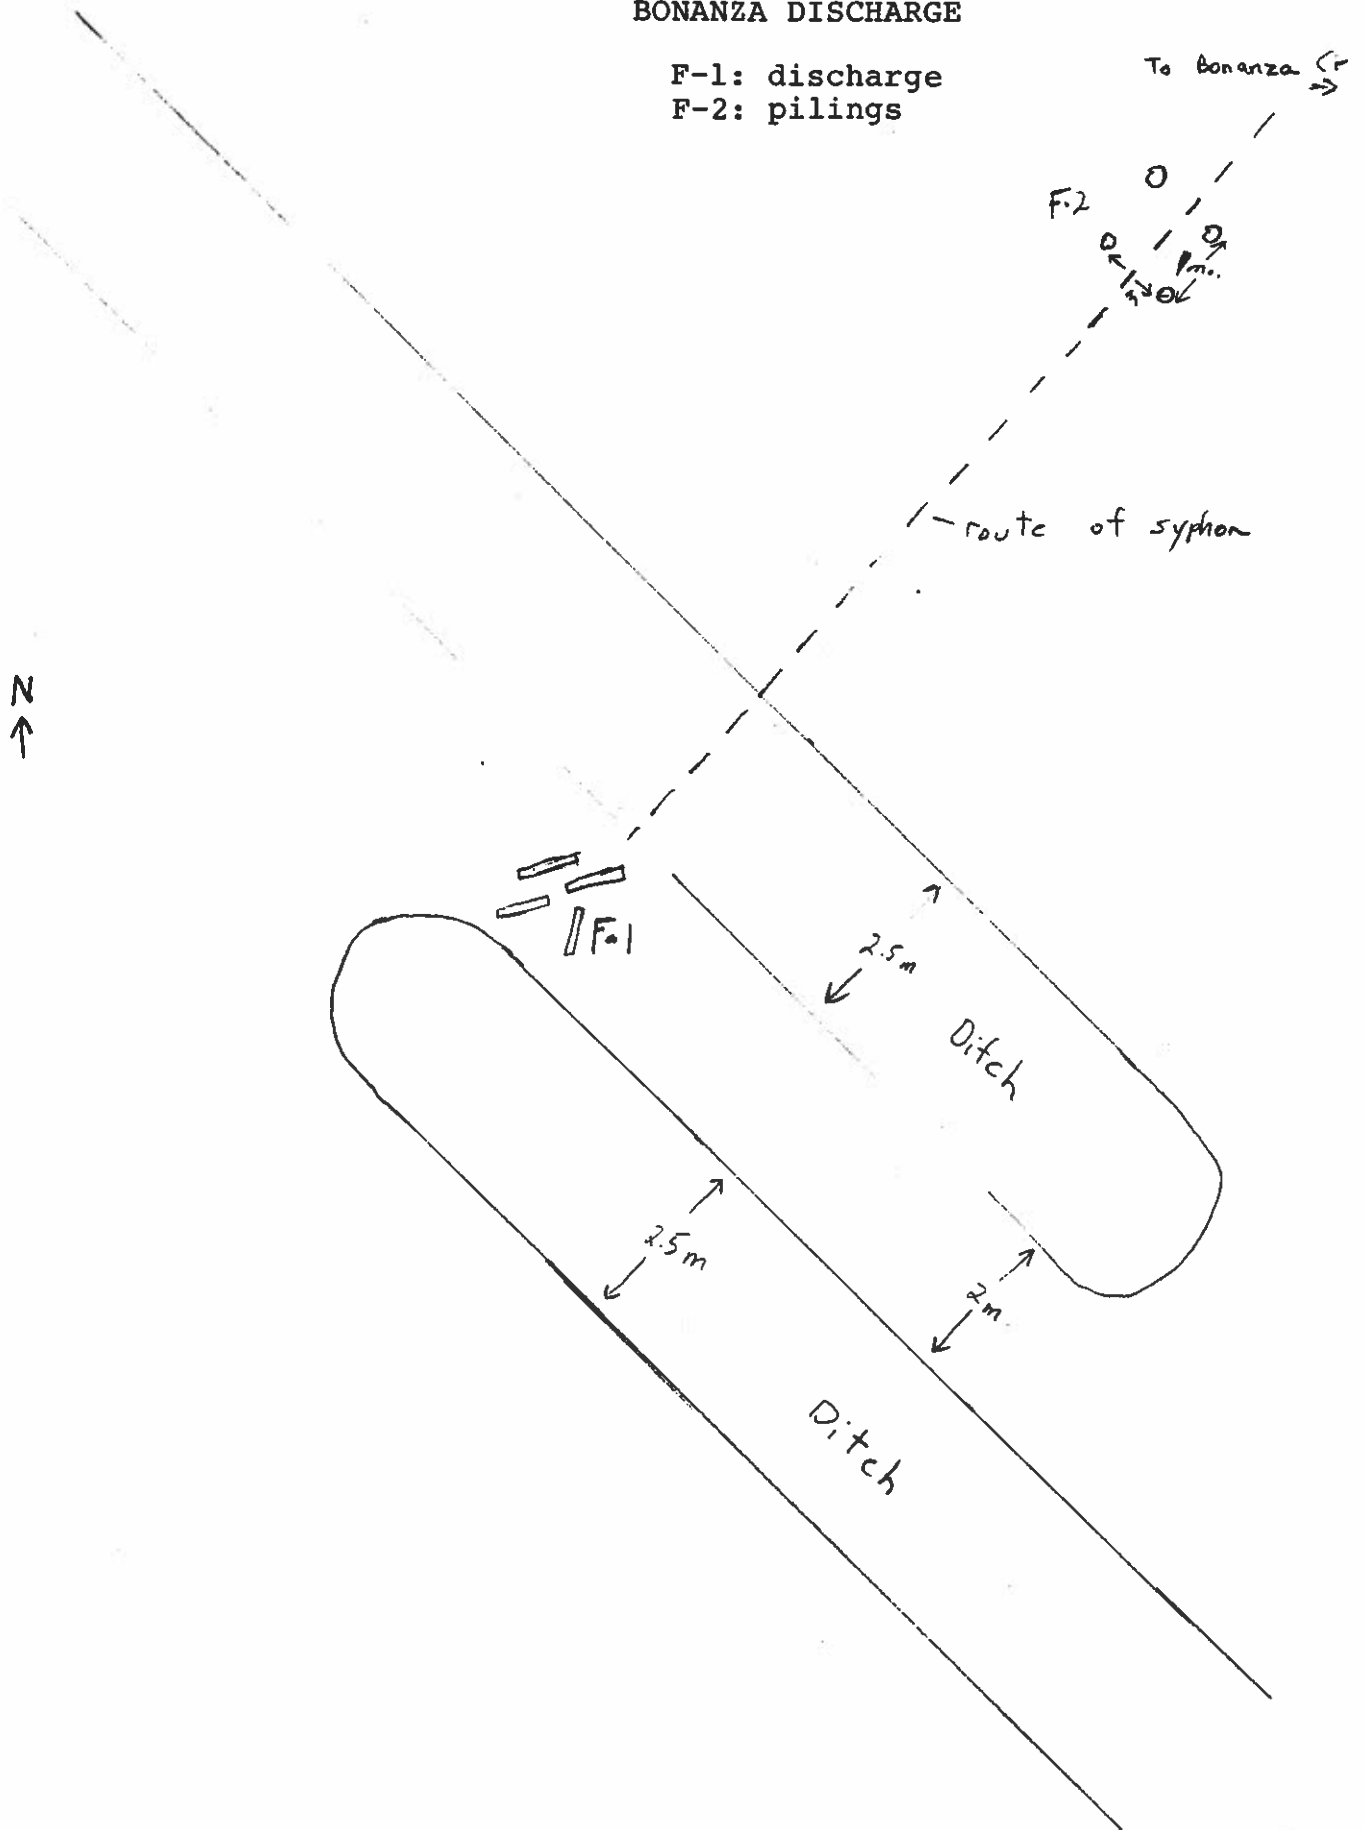
SITE 15

Feature One: Pilings from pipe support system. Fair condition, piling built up to support pipe crossing the Bonanza Valley. Some of the pilings were cribbed and filled with rock.

Feature Two: Remains of a pressure box where the pipe converts to ditch. Only visible remains are footings and loose boards scattered on the ground. Poor condition.

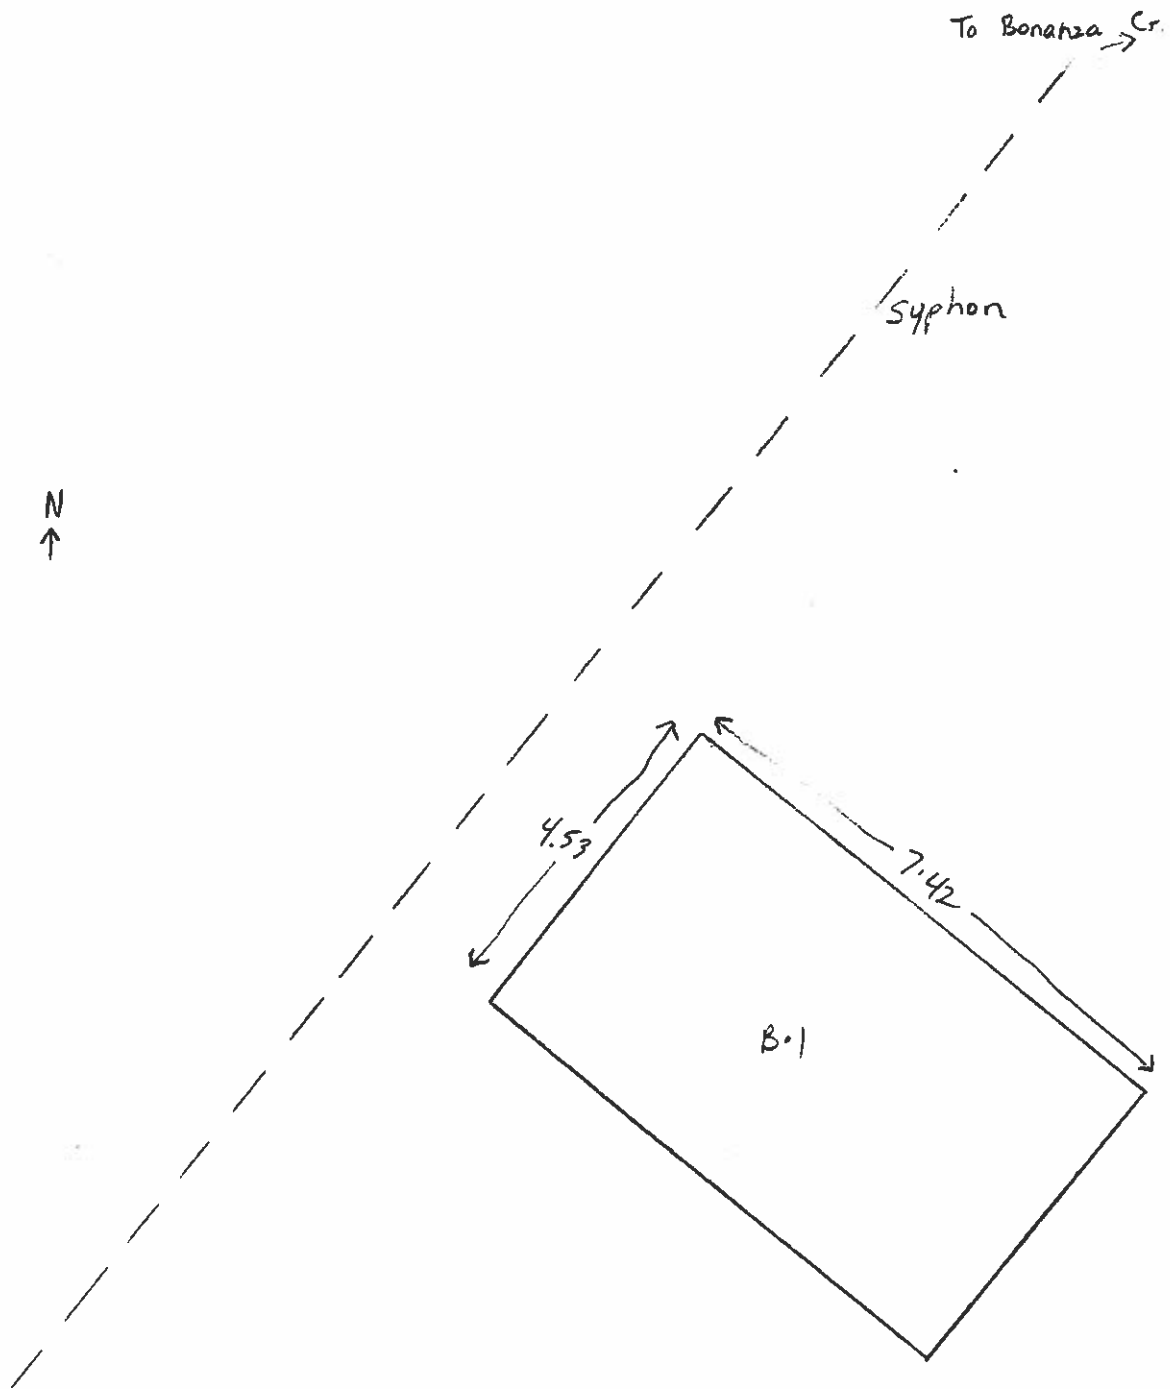
SITE 16

Building One: Coffey's office, log cabin in good condition. Pole and tin roof, most of tin missing. Walls saddle notched log, interior planked. Foundation sill logs rotting, floor heaved. Believed to have been G. Coffey's office, superintendant of hydraulic operations. Artifacts recorded, wheel barrow, hammers, bolts, cookstoves, heater, pencil sharpener beside building. Ventilator and chimney safety in roof.

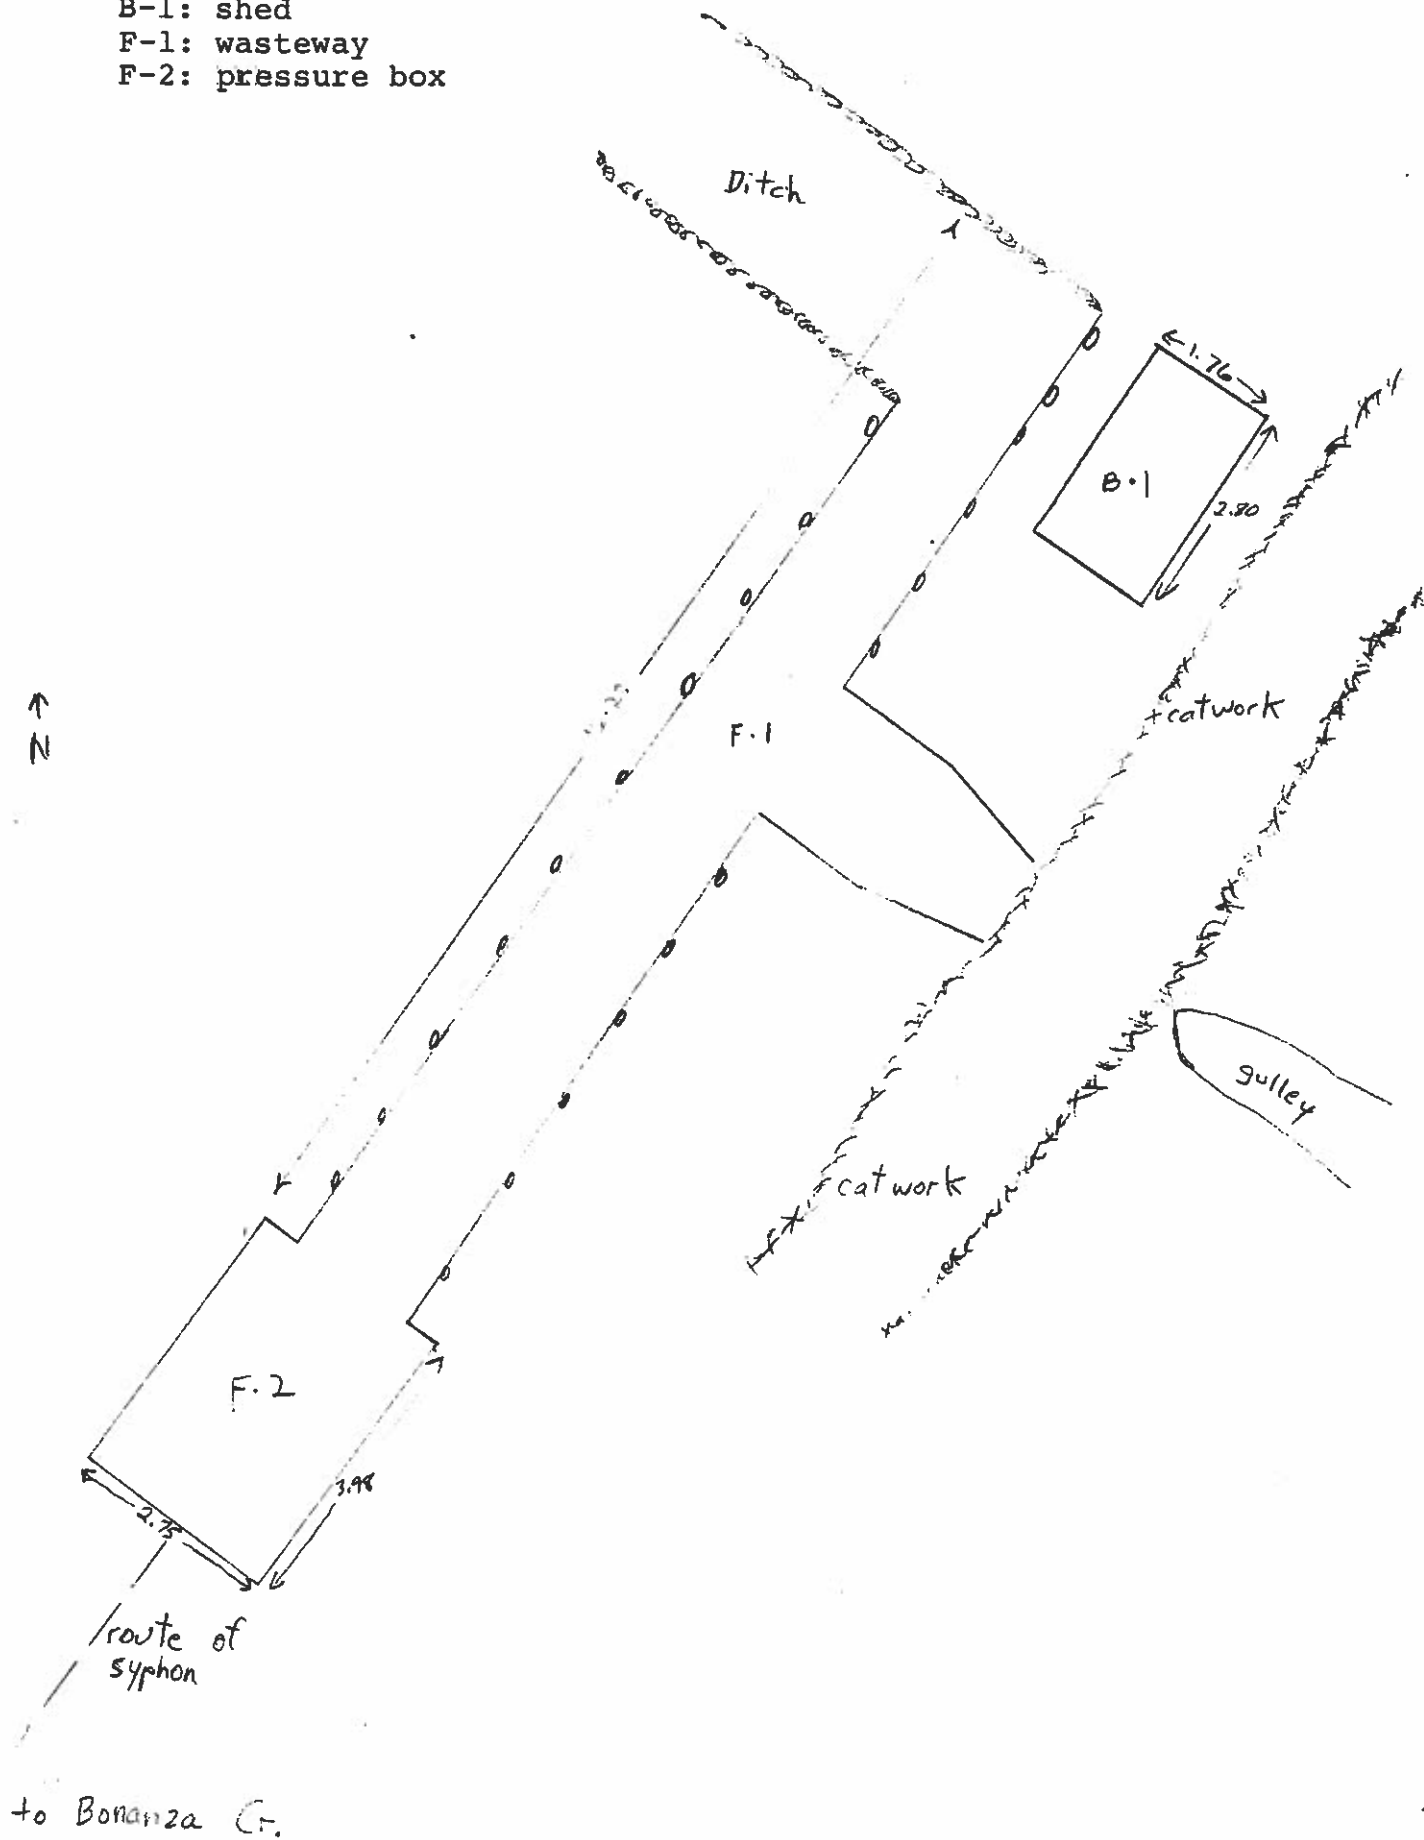
SITE 17

Building One: Collapsed post and beam shed. Walls are board or plank and collapsed, roof, windows, doors missing. Artifacts recorded, stove pipe, enamel pail, sheet metal, large bolts. Located in close proximity to the ditch.

Feature One: Wasteway or spillway. Frame construction and excavated earth. Poor condition, boards scattered and rotten, earthen banks sloughing.

Feature Two: Pressure box and flume. Fair condition, front of box is cut out, flume is collapsed and rotten.

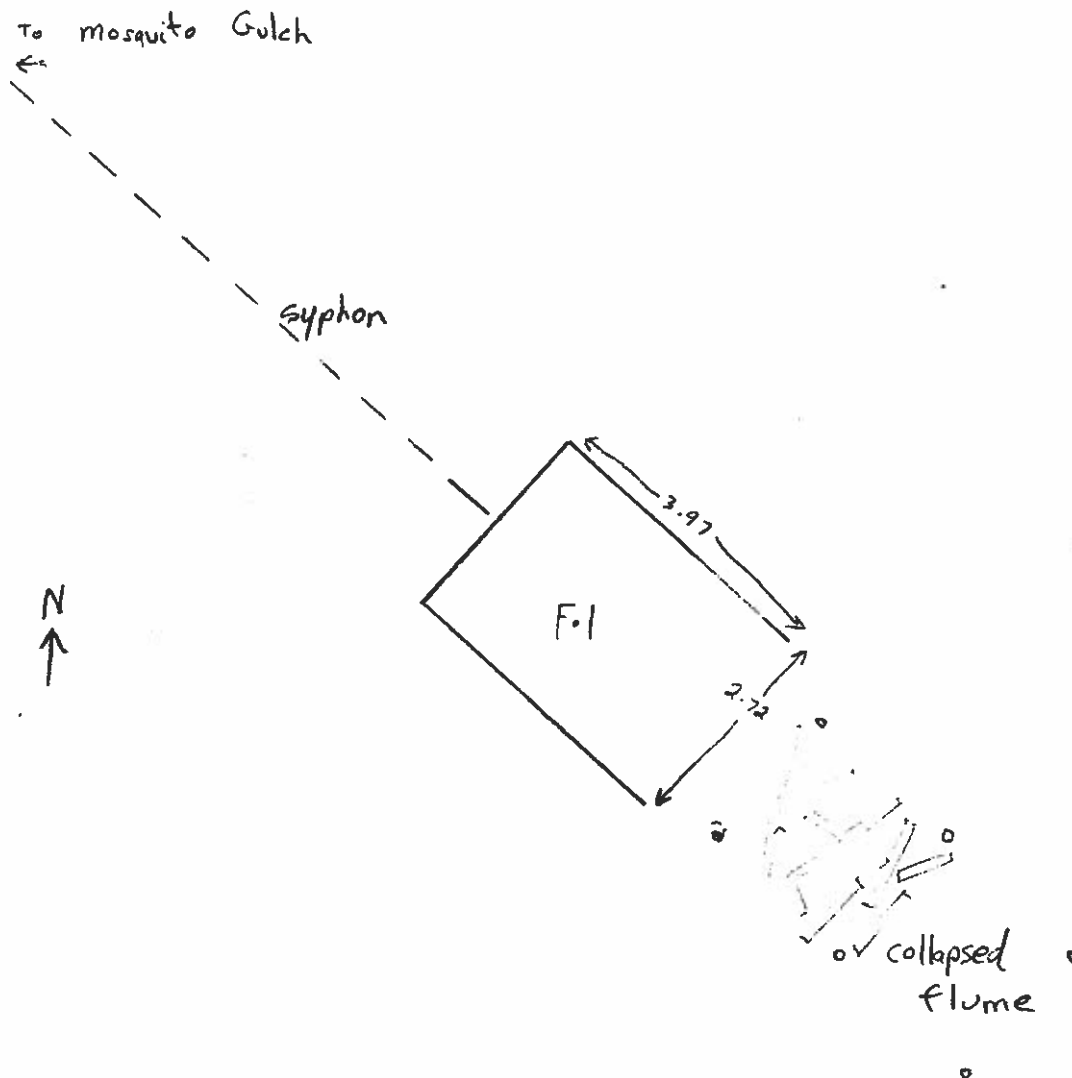
SITE 18

Feature One: Pressure box and flume in good condition. Board and batten on pressure box and flume. Artifacts recorded, metal bands from wood stave pipe. Pipe is missing.

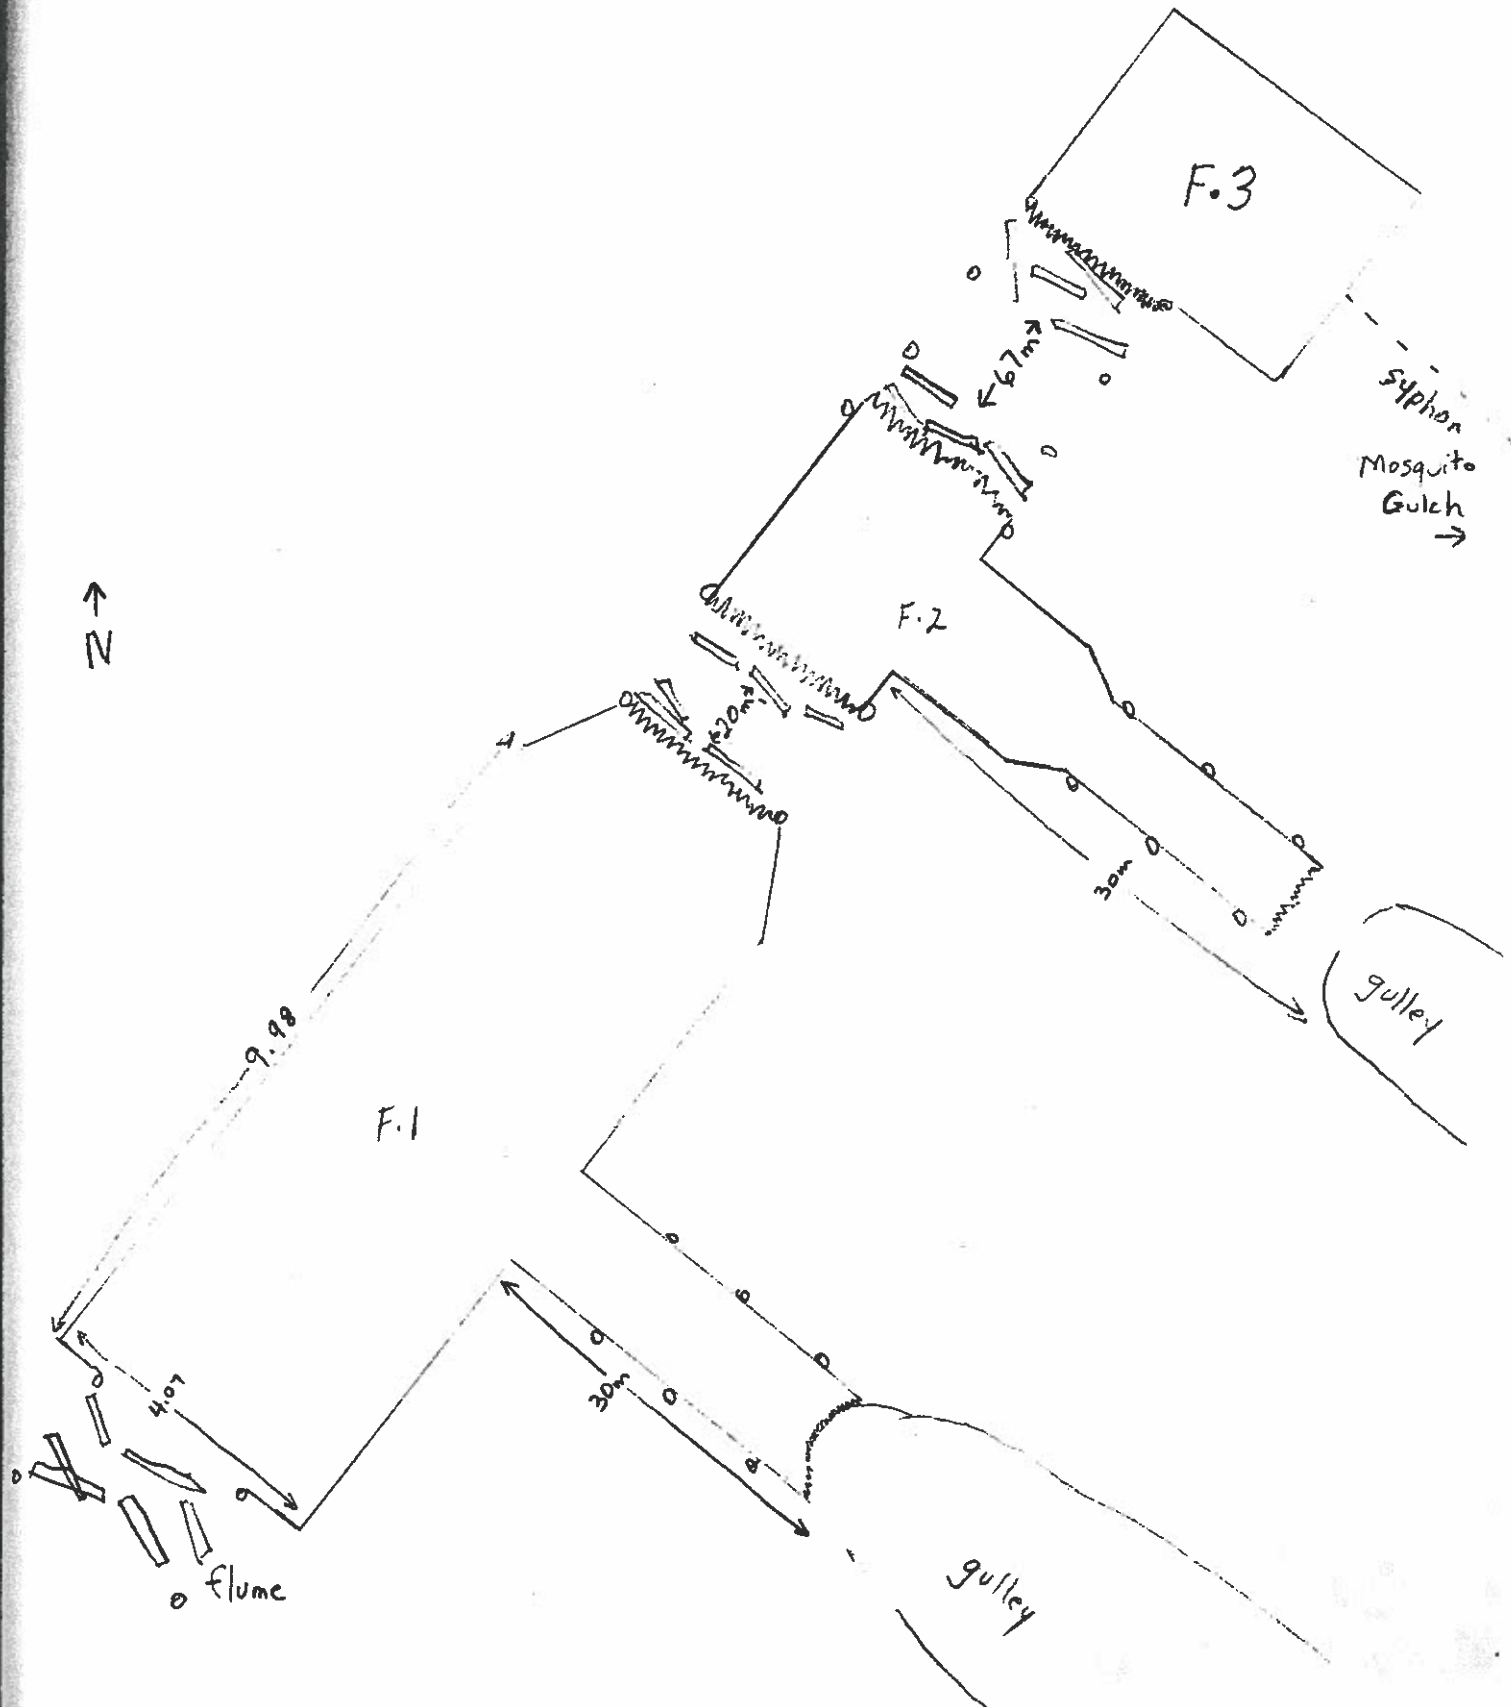
SITE 19

Feature One: Sandbox or settling box. Board and batten in good condition, some boards fallen and rotten. Series of gates on downhill side used to clean out debris and dirt that had

Feature Two: Wasteway or diversion. Poor condition, partially collapsed. Board and batten.

Feature Three: Pressure box, fair condition. Board and batten painted red. Notched beams on top holding box together. Flume entering from the back, pipe missing in the front.

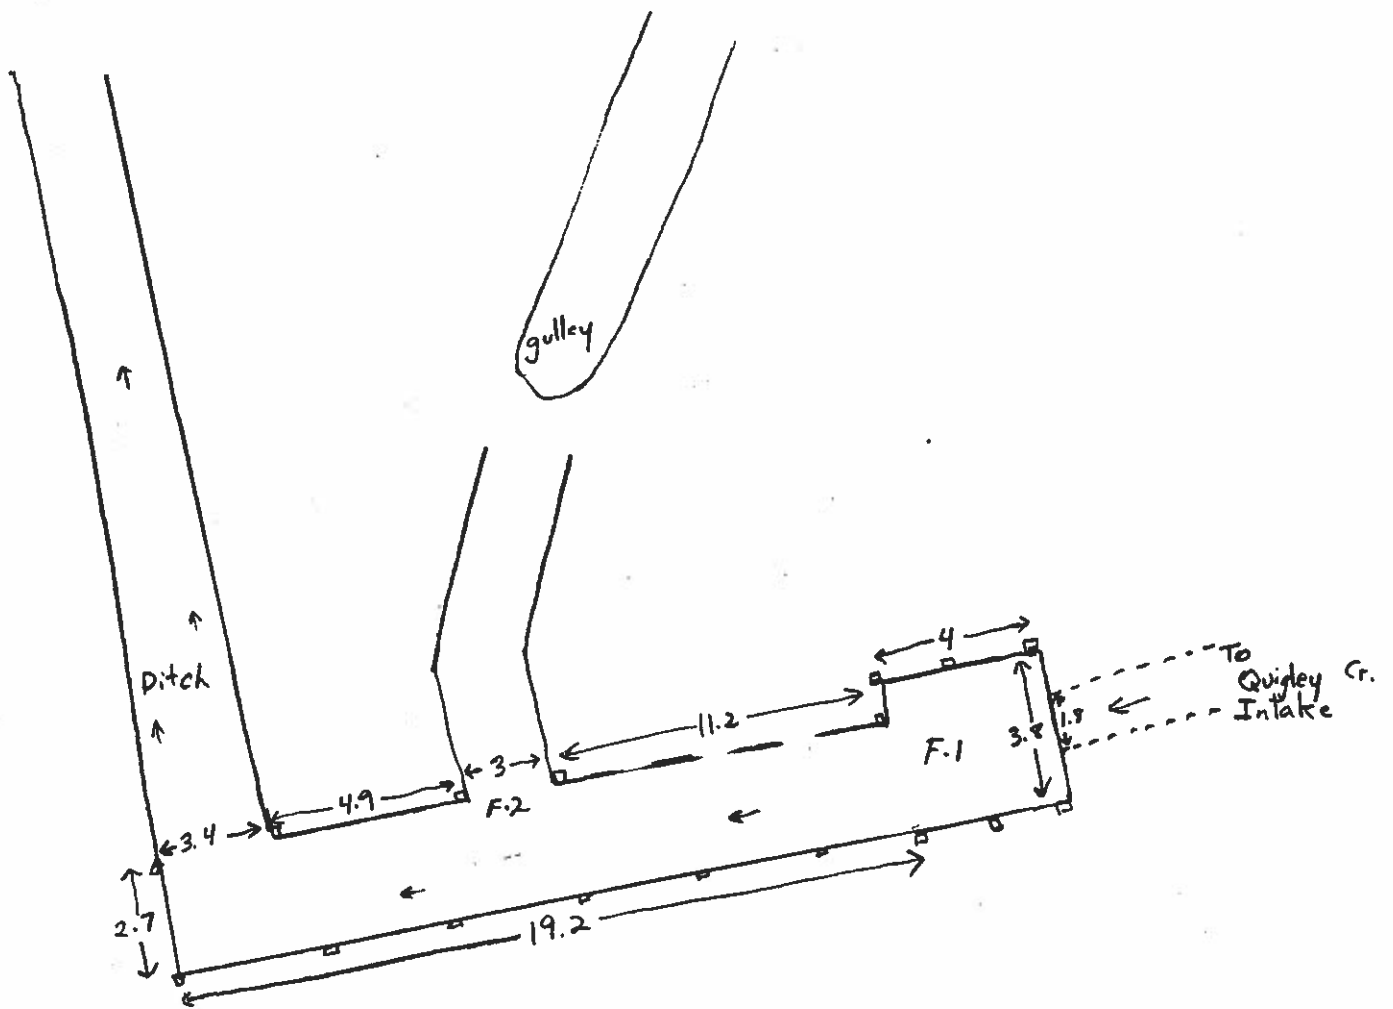
SITE 21
QUIGLEY GULCH DISCHARGE
F-1: pressure box
F-2: wasteway

Feature One: Pressure Box, fair condition. Board, batten and timber construction with flume entering from the rear and pipe missing in front.

Feature Two: Wasteway or diversion, poor condition. Board and batten construction. Used as a simple overflow for excess water in system.

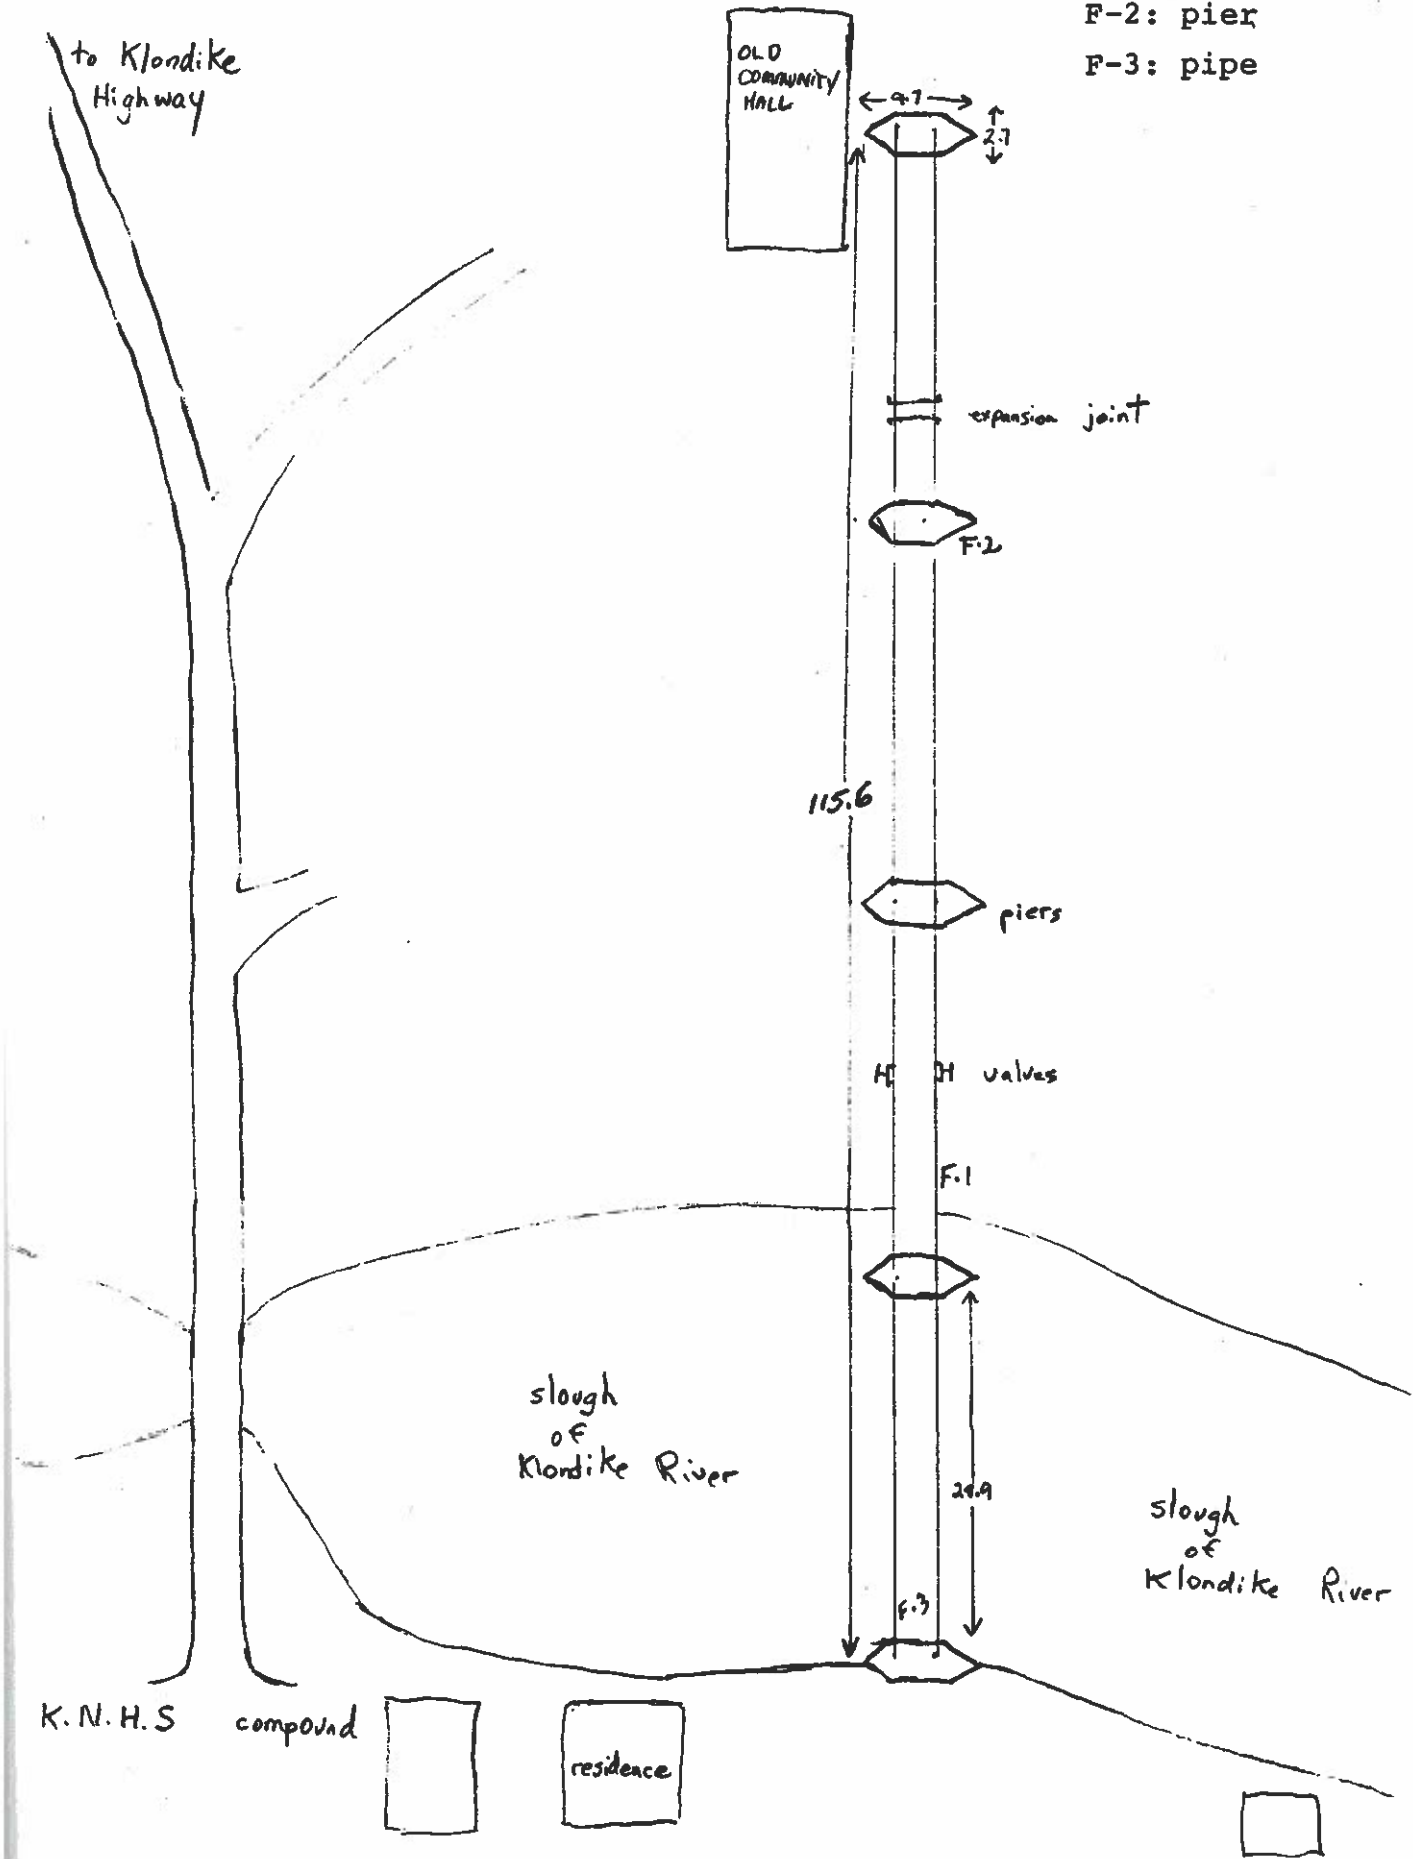
Feature One: Bridge, good condition. Steel bridge made from I beam, angle and flat iron rivetted together and tightened with turnbuckles on steel rods. Supported pipeline for Yukon Ditch and traffic (horses and narrow motor vehicles) to other side of Klondike R.

Feature Two: Pier or bridge support, fair condition. Constructed from mortised timbers and clad with steel in a pointed shape in order to deflect driftwood and ice flowing down Klondike River (this was the main channel at the time).

Feature Three: Pipe, very good condition. Imported from Germany, 11/16" thick in order to withstand high water pressure at the lowest point in the inverted syphon.

Another site to be considered should be the Klondike Crossing, which is by far the most available to public access, and is the largest valley that the Yukon Ditch crossed. There is a considerable amount of archival material available on this crossing, including blueprints and engineer's drawings.

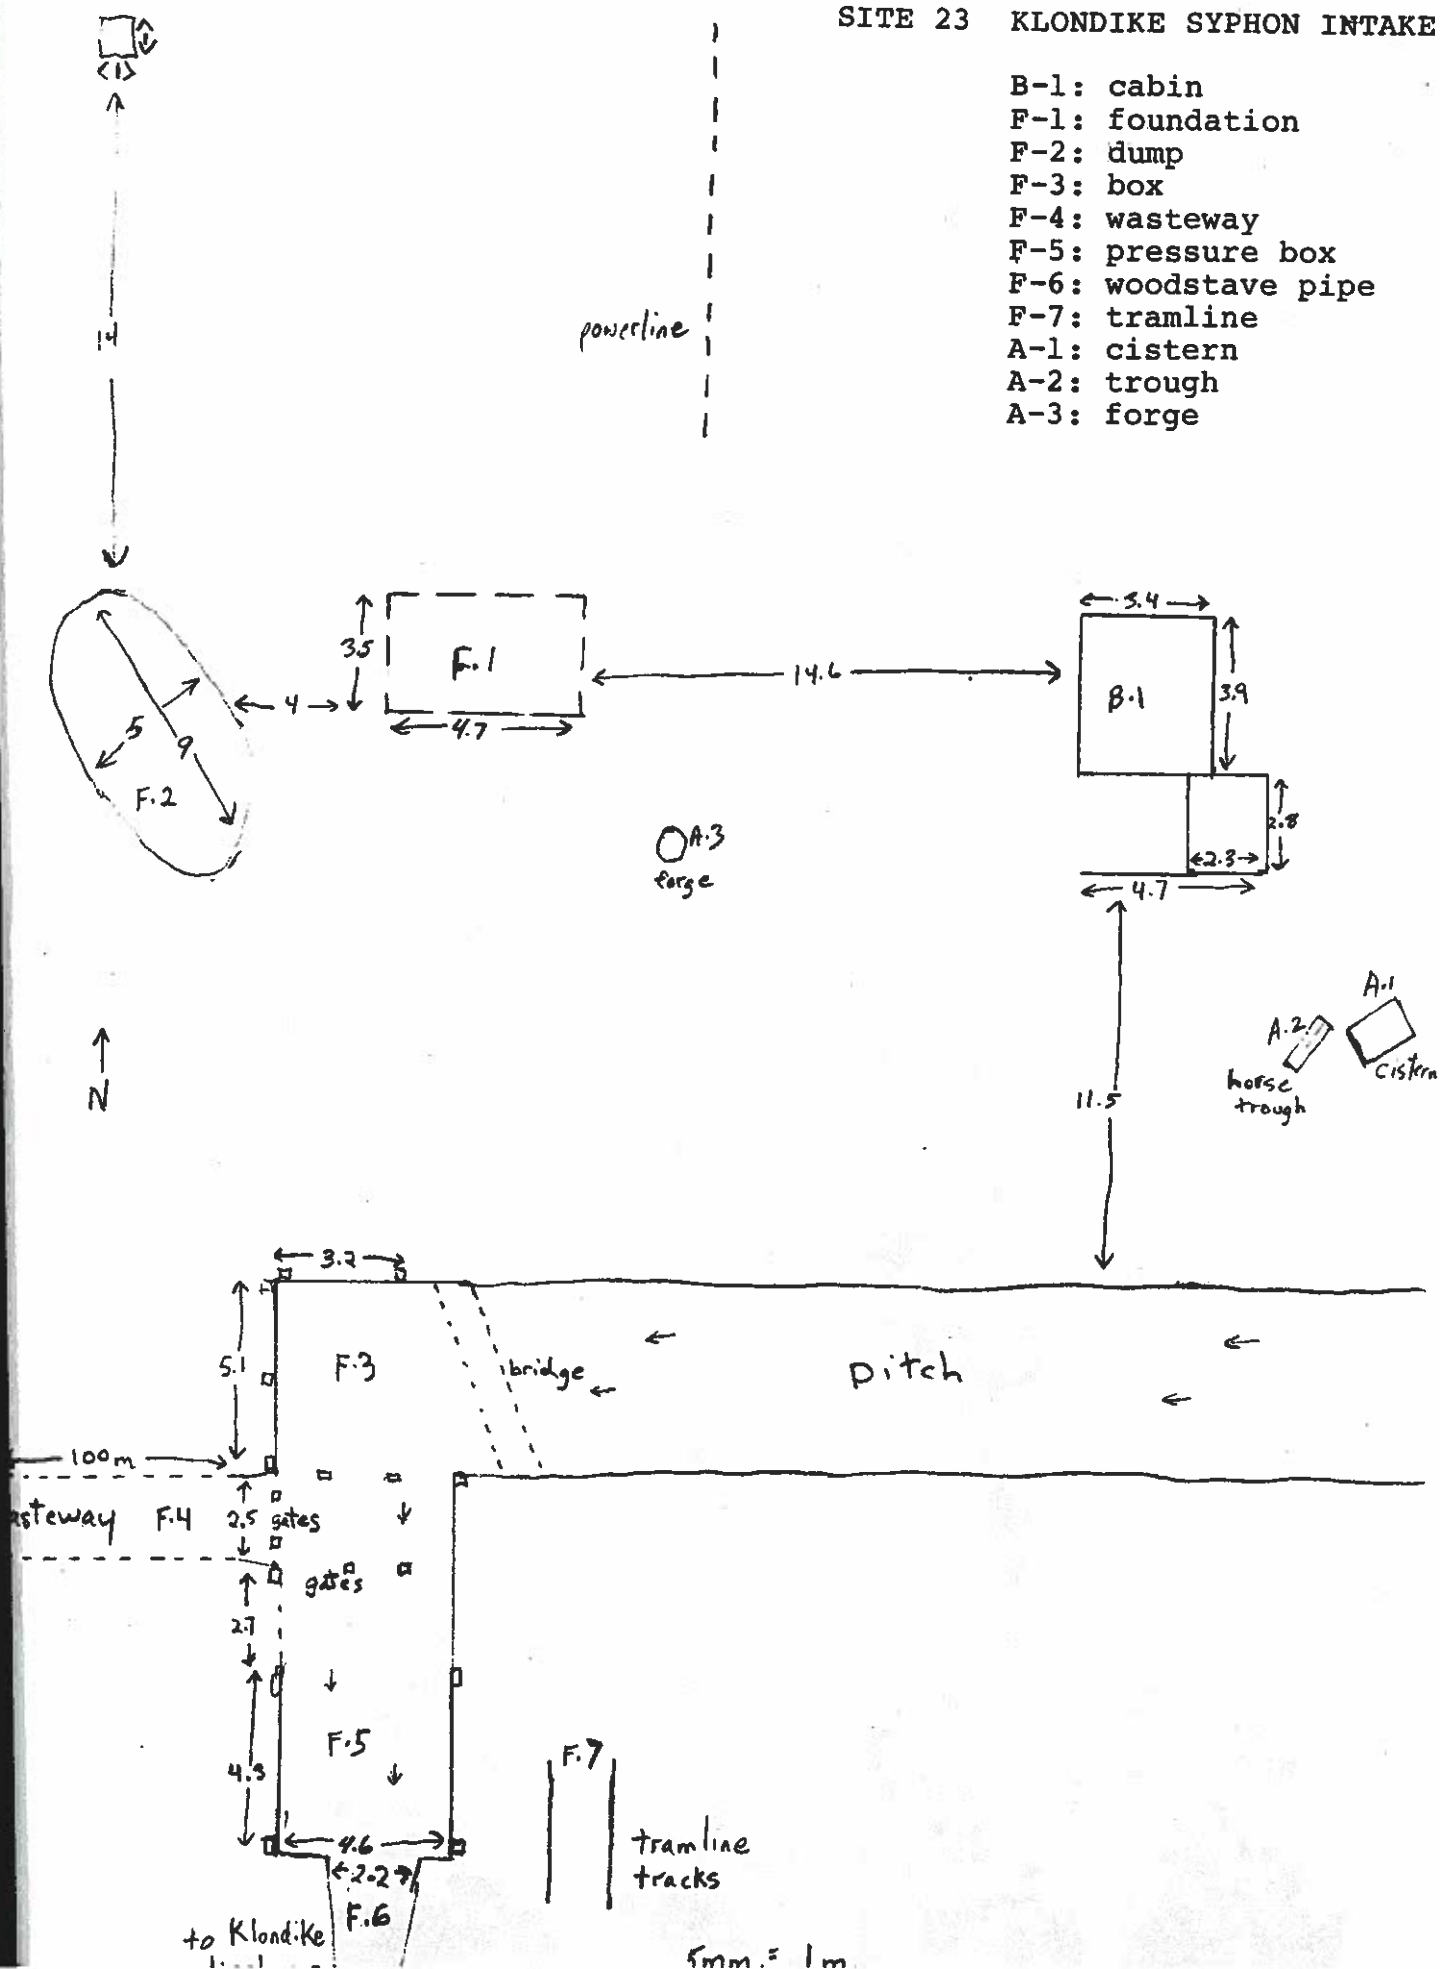
SITE 23 KLONDIKE SYPHON INTAKE

Building One: Cabin, fair condition. One room with attached shed for tool storage, built from framed spruce planks with a tin roof. Used by one or two men to maintain water levels and carry out repairs on the system. Artifacts noted include chairs, tables, bed frames, enameled dishware, telephone, cookstove, heater, lanterns, sawblades, grub-hoes, pick-axes, and wrenches.

Feature One: Collapsed building, poor condition. Frame construction, probably used as a bunkhouse for extra workers during construction of the syphon.

Feature Two: Garbage dump, fair condition. Mostly tin cans, bottles, and broken tools and domestic items.

Feature Three: Box, poor condition. Timber and frame construction for collecting water from the ditch and diverting it to the pressure box, allowing for some settling of silt and debris to minimize wear of the pipeline.

Feature Four: Wasteway or diversion, poor condition. Board and batten construction designed to carry excess water away from footings of pressure box and pipeline. System could allow all water to be diverted through a gate into wasteway, thereby allowing repairs to be carried out on syphon.

Feature Five: Pressure box, fair condition. Timber and frame milled from local spruce. Used to contain water at an adequate level before entering pipeline-reinforced with steel rods to withstand water pressure.

Feature Six: Penstock, fair condition. Redwood planks tapered from the top and bound with steel rods that could be tightened as the planks shrunk. Used to direct the flow of water from the pressure box to the steel pipe partway down the syphon.

Feature Seven: Tracks from tramline, fair condition. Steel rails made from light gauge steel used during construction of syphon to carry sections of pipe up the hill and position it. The tram was probably powered by an electric motor and used during regular operations of the ditch for transporting supplies.

Artifact One: Cistern, good condition. Section of pipe covered at one end with planks-may have been used to contain water for domestic purposes.

Artifact Two: Trough, good condition. Built from planks in board and batten style to contain water, likely for horses.

Artifact Three: Forge, fair condition. Steel with hand-cranked bellows used for heating metal to melting point for welding, shaping horseshoes, and sharpening digging tools.
