ERT and Temperature Monitoring to Assess the Effectiveness of Insulating Culverts on Northern Highways

Northern Climate ExChange
YUKON RESEARCH CENTRE • Yukon College

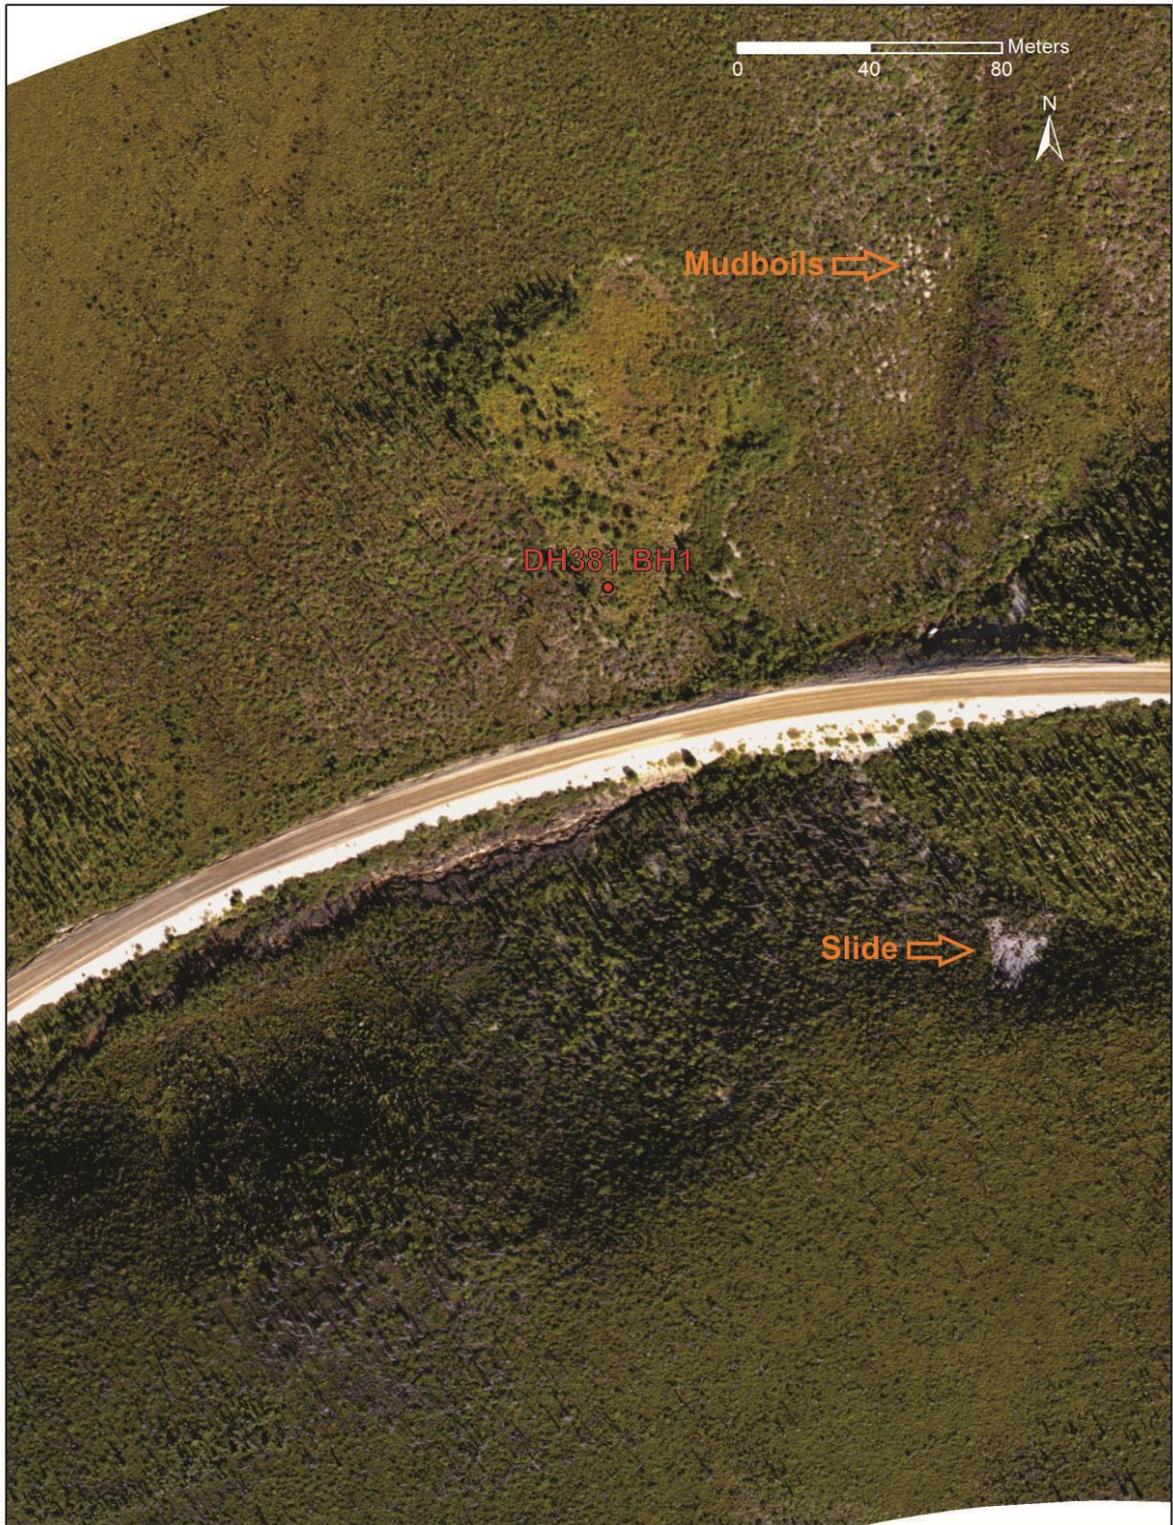
Figure 2.3 Aerial view of site km 381.

The site is located in the lower part of a small valley. Two interesting features providing information about the geomorphic context can be seen in the aerial imagery (Figure 2.3). First are some mud boils (AKA frost boils), which are upwellings of mud that occur through frost heave and cryoturbation in permafrost areas. A group of them is visible about 100 m into the field at the left-hand side of the road. The mud boils are good indicators of a fine-grained, frost-susceptible material, i.e. potentially ice-rich ground. Second, a small slide is visible on the slope about 70-80 m from the road, on the right-hand side.

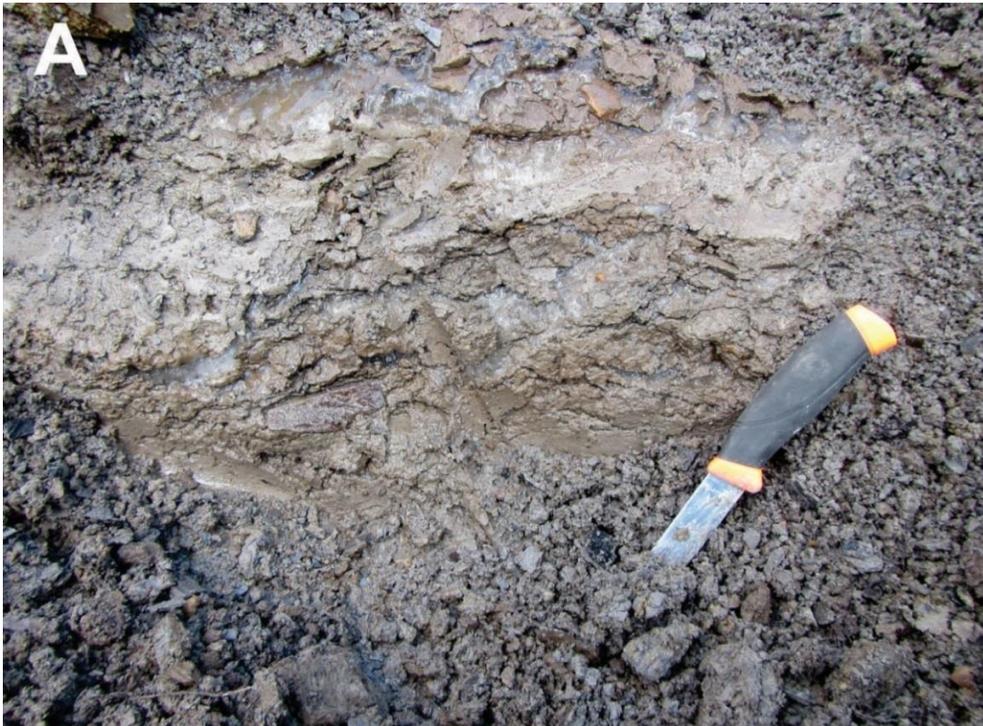
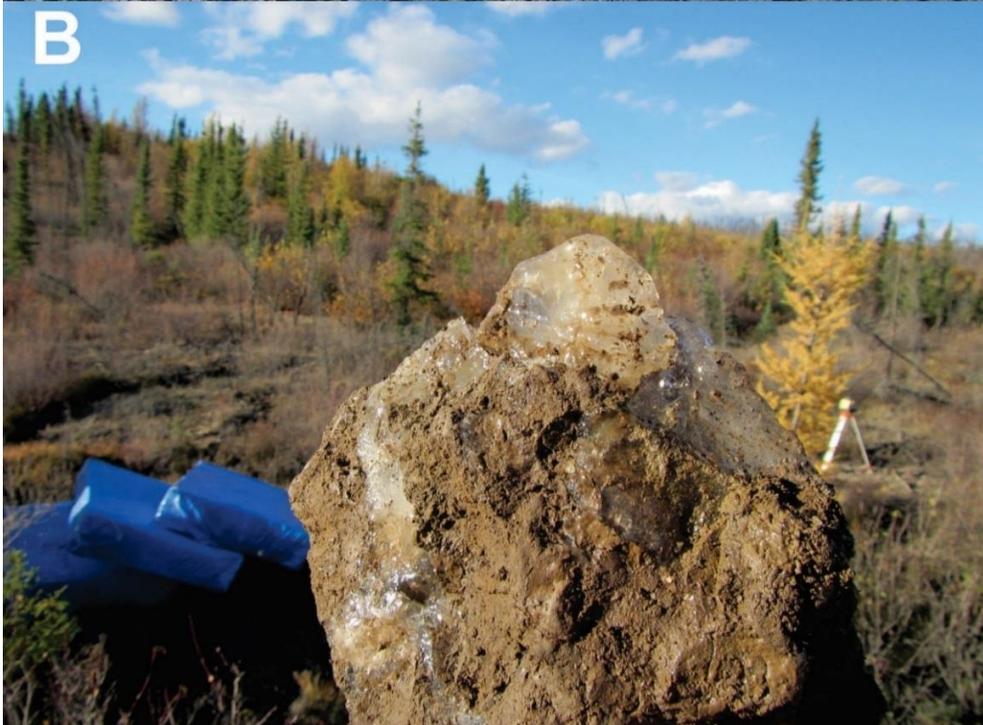
Figure 2.4 Permafrost observed during culvert installation at site km 381. A- ice-rich fine grained soil excavated below the embankment; B- close-up of an ice-rich permafrost sample collected during the excavation works

Permafrost was directly observed during installation of the culvert, when the excavation extended below the road embankment. The ground was fine-grained and ice-rich (Figure 2.4).

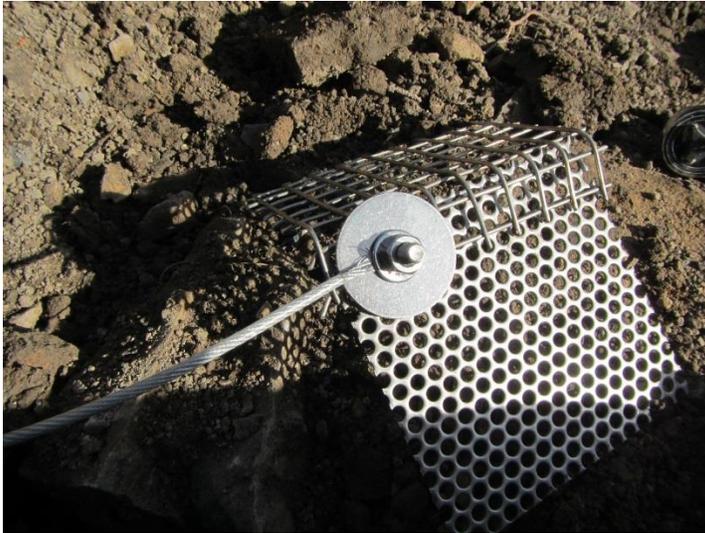
Figure 3.7 Stainless-steel mesh and perforated plate electrode.

The electrode is made of two elements, a stainless-steel mesh plate and a stainless steel perforated plate, attached together at a 90° angle using stainless-steel bolt and washers (Figure 3.7). All the parts, including the electrode wire, are made of stainless-steel to prevent corrosion and ensure good electrical conductivity. Because the electrode cannot have dimensions exceeding 10% of the distance between electrodes, the plates are 10 by 10 cm square with a 1-m spacing. Mesh and perforated plates have been chosen to have maximal surface contact with the ground, therefore favoring a good transfer of the electricity from the electrode to the ground.

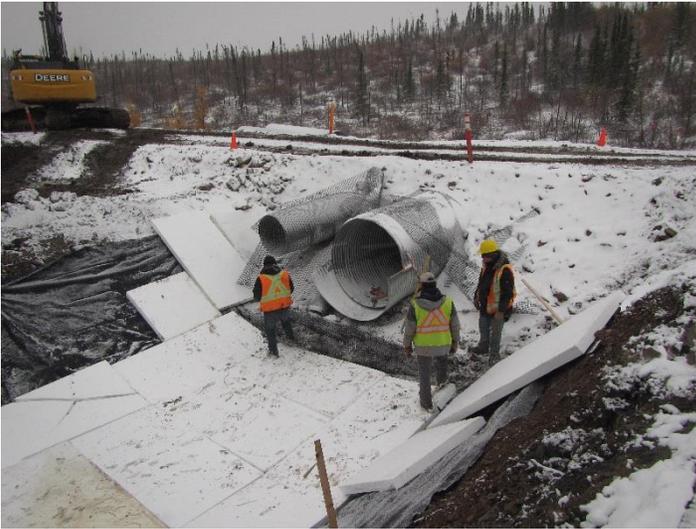
Figure 3.11 Construction of the culvert at right-hand side of the road. Note the secondary culvert located left of the main culvert. As there was an insufficient supply of foam, some areas remained uninsulated at both sides of the culvert.

Additional layers of geogrid were added during the build-up of the embankment, as well as a secondary culvert located downslope at a higher level (Figure 3.11). Because the contractor did not bring enough supply of insulating foam, approximately one third of the total length of the culvert installation lacked insulating foam along the sides of the culvert (toward the right-hand side), as well as at the end underneath the culvert at the right-hand side (Figure 3.12). Measurements were made during construction by NCE team members to exactly record the shape and location of each element of the setup, including the areas missing insulating foam. This should allow for production of an accurate three-dimensional representation to be used in a 3D model, if required.

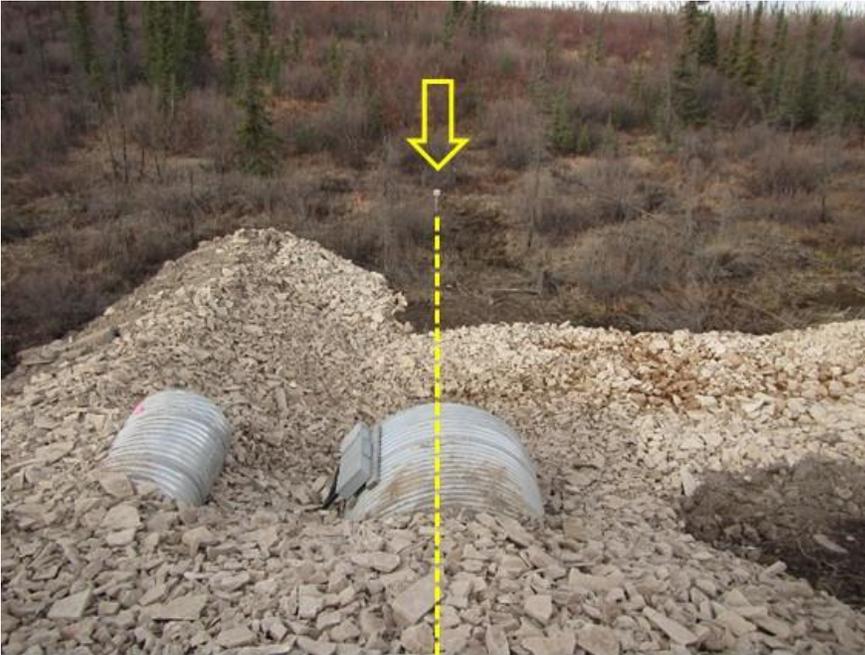
Figure 3.14 Borehole DH381 BH1, located in the field, right-hand side, aligned with the center of the culvert and the buried monitoring array lines (location of the station indicated by the yellow arrow).

In addition, Borehole DH381 BH1 was drilled in the field at the right-hand side using a waterjet drill (i.e. no cores were collected). This borehole was aligned with the center of the culvert, and with the ERT and temperature arrays below the culvert (Figure 3.14). The drilling reached a depth of 4.55 m within fine-grained material. The borehole was lined with PVC piping and instrumented with one 4-channel Hobo logger to record ground temperatures at 0, 1.0, 2.0, and 4.55 m depths. Ground temperature recording started on September 29th, 2016.

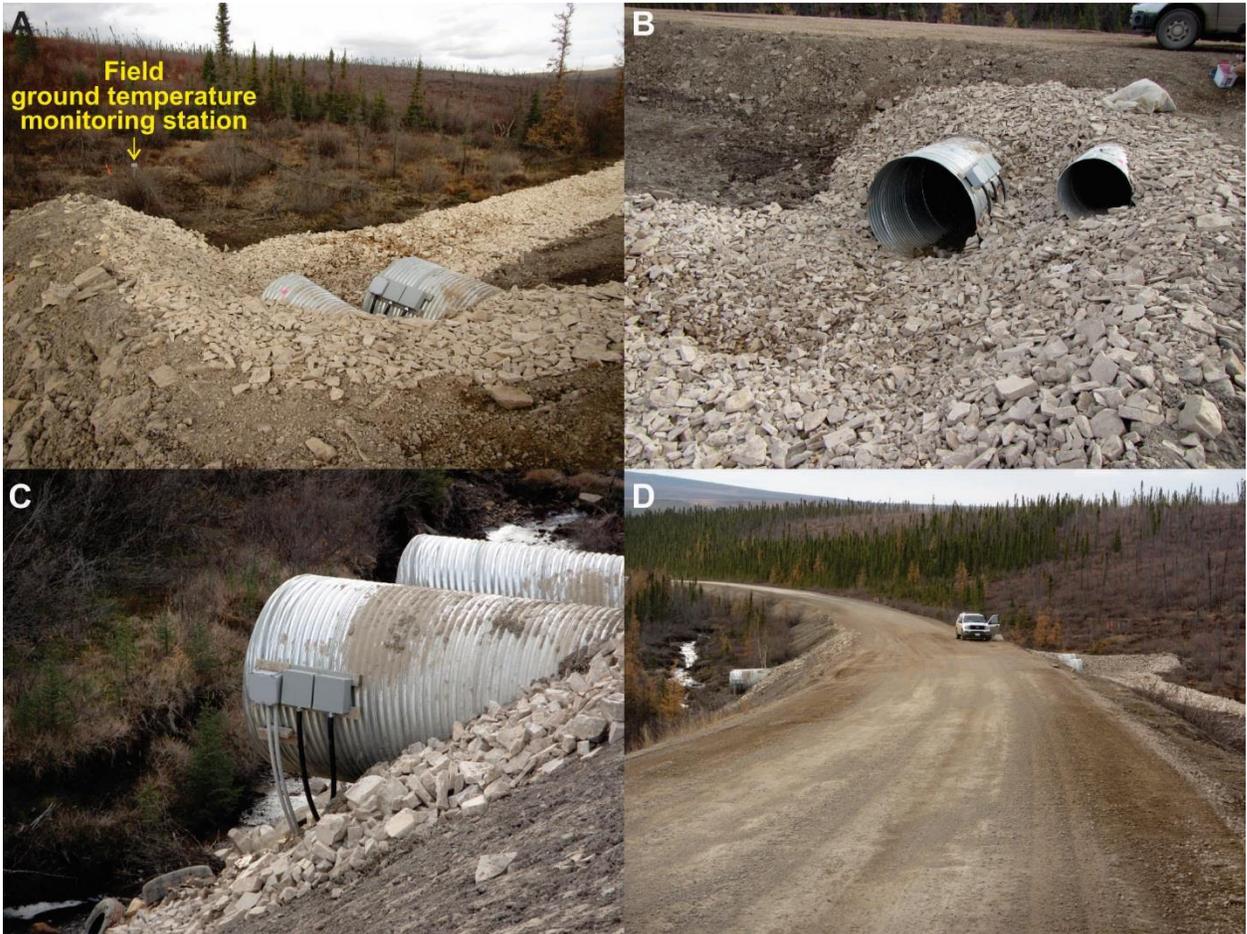
Figure 3.15 Culvert site at km 381 after construction. A- view from the road on the left-hand side showing the station monitoring the natural ground temperature in the field; B- view from the field showing the left-hand side of the embankment; C- view from the road of the right-hand side; D- general view of the site from up-slope.

The final configuration of the site is presented in Figure 3.15 (following page).
